FROM: Iowa FACE Case No. 2003IA022 Report Date: 06 July 2009

SUBJECT: Tractor with Cable Hitched High to Tow Brush Overturned Rearward on Farmer

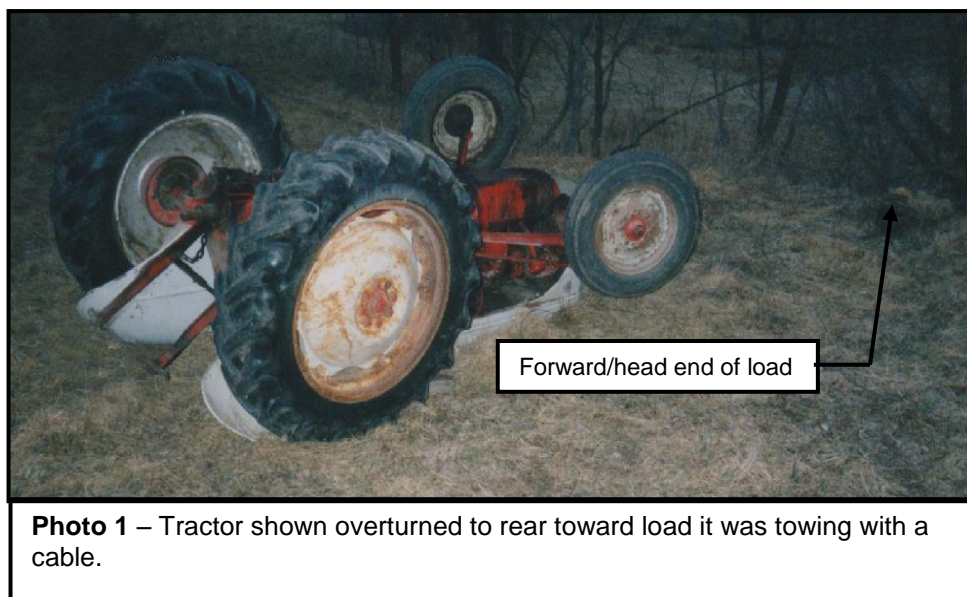
A 56-year-old farmer from east central Iowa died early in the spring of 2003. He was clearing brush, limbs, and fallen trees from along a creek gully at the edge of a pasture on his farm. A strip of level ground separated the creek from a berm that ran parallel to it and hid the work area from view of the farmstead. He was dragging the load
