FROM: Iowa FACE Program Case No. 2005IA004 Report Date: 23 September 2005

SUBJECT: Part-time Metal Salvager Died when Crushed in Tractor Overturn with Loader

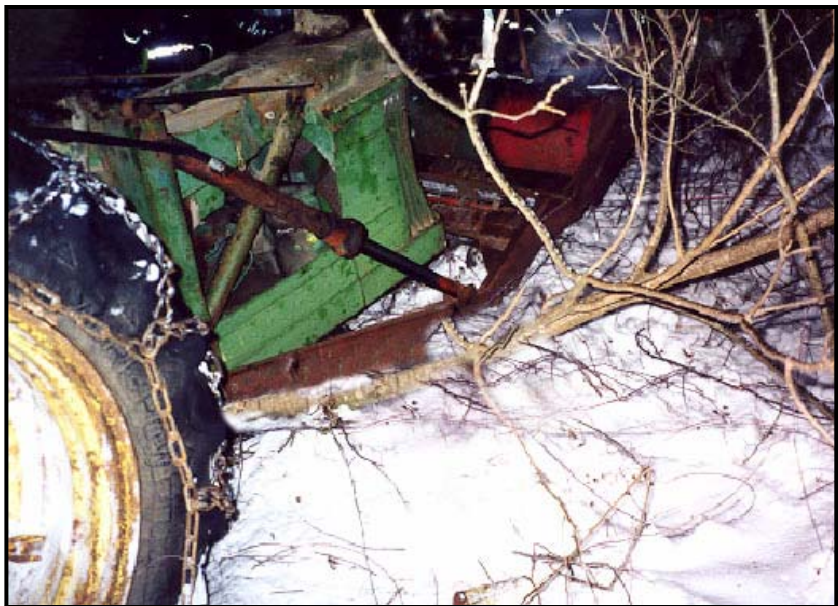
Photo 1 – Victim (not shown) was pinned against tree with loader frame across his abdomen.

pinned between the tractor and the tree with the lift arm of the loader frame across his abdomen (Photo 1). His brothers who worked with the victim in their scrap metal salvaging enterprise found him hours later, after midnight. Emergency medical services were called and arrived within ten minutes. No life signs were detected and it was determined the victim died at the scene.

During the overturn, the man either jumped or was thrown from the operator's station. His lower body was subsequently pinned across a small, bent-over tree. With the rear of the tractor swung somewhat downhill, his legs were partly under the tractor hood near its exhaust stack with the lift arm of the raised loader across his abdomen. The loader was in a partially raised position with the bucket about the same height above level ground as the top of the tractor's hood.

1. *All tractors used with front-end loaders should be equipped with a ROPS and seat belt.*
2. *ROPS should be designed for all tractor makes and models in common, productive use and owners should have ROPS installed or retire these tractors from active use.*

Recommendation #1 – All tractors used with front-end loaders should be equipped with ROPS and seat belt.

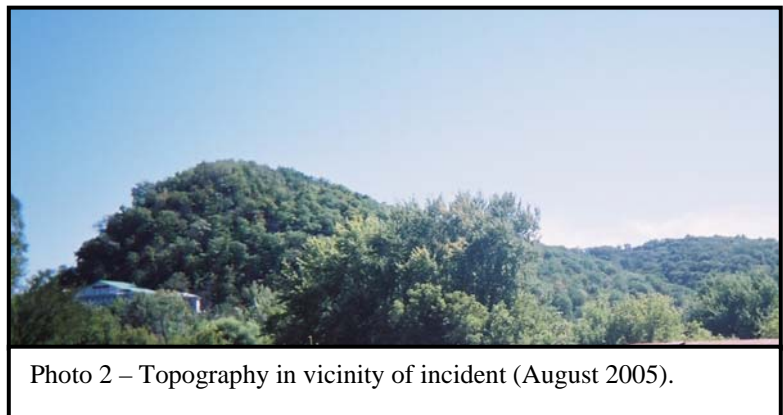
The leaves had fallen exposing the round-topped bluffs (Photo 2) that surrounded the town where this part-time metal salvager lived. His assigned task for the morning was to drive his tractor with loader a few short blocks to the edge of town and go up the bluff to collect some scrap metal from the back of a neighbor's property. On the way down the bluff his tractor overturned pinning him underneath.

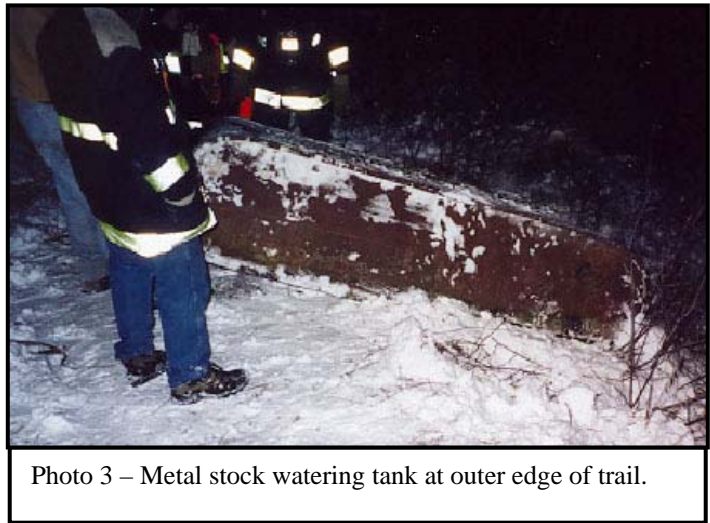
He drove his tractor to the edge of town and navigated his way up the steep trail to the back of his neighbor's property to salvage the thin-walled, metal water tank. It was an open, oval-shaped tank about 8 feet (2.4m) long, 2-3 feet (0.6m – 0.9m) deep and about as wide (Photo 3). He emptied snow and debris from the tank, then hoisted it with the loader and steered forward down the trail.

Apparently, control of this light but awkward load was difficult to maintain. Markings on the ground indicate the tank had to be retrieved and reloaded at least twice along the upper portion of the trail. Tire skid marks on the path immediately before the incident site suggest the application of the tractor's brakes as one might do if the load was about to come loose. In the process of retrieving the tank which may have fallen or been brushed loose toward the outside edge of the trail, the tractor with its loader was positioned at a slight angle to the trail, aimed toward the tank and somewhat toward the ravine which sloped steeply downward from the trail's outer edge.

Proper attachments and means to secure loose, awkward, or shiftable loads should be used to prevent losing control of the load.

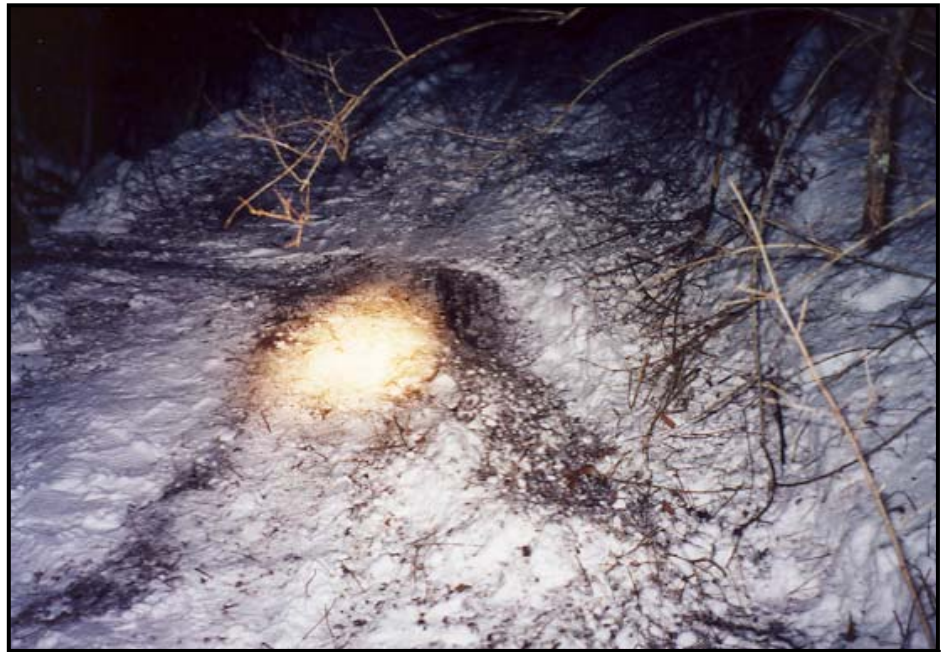
Marks on the trail made by rear wheels spinning indicate he placed the tractor's transmission in reverse, engaged the hand clutch and began backing up aggressively to reposition the tractor, its loader and load, on the narrow pathway (Photo 4). Chains around the tractor's rear wheels dug into the snow and ice backing up the grade of the trail. The rear of the tractor slipped to the right on the

trail and away from the bluff as the wheels continued to churn. First the right rear wheel then the left went off the outer edge of the trail. The tractor and front-end loader overturned down the wooded hillside coming to rest upside down 40 feet (12m) down hill from the trail.

Photo 4 – Tracks of spinning rear wheels as tractor backed up grade of trail then slid to its right off edge of trail.

Recommendation #5 – *Operators should use extreme caution when operating tractors on or near steeply sloping terrain and on pathways with ditches or embankments.*

Discussion: Losing and having to reload and regain control of the tank multiple times along the upper section of the trail would frustrate and irritate many tractor operators. Repeated difficulty could have been prevented if the load had been secured or if different equipment such as a trailer had been used. Tractors used on or along steeply sloping terrain should be equipped with ROPS.
