FROM: Iowa FACE

Case ID: 2005IA075

Report Date: 07 March 2007

SUBJECT: Farmer Fatally Injured in Tractor Posthole Auger Entanglement

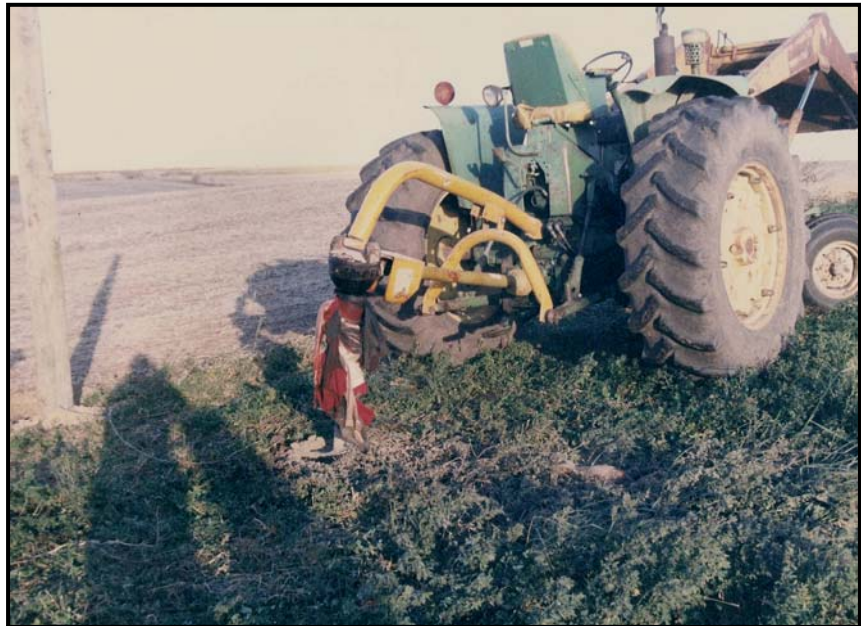
Photo 1 – Tractor shown with three-point hitch, PTO-powered posthole digger attachment as it was found early in the morning after the incident.

ground level around the auger had been spread away from where the auger entered the ground. A shovel with a broken handle was found at the site and a loose strand of barbed wire snaked along the ground between the tractor and auger. The victim's shirts were wrapped around the top of the auger. There was no guard in place in this area where the auger connects to the gearbox output shaft. The incident resulted in amputation of the victim's right arm and multiple blunt force wounds. He was dead when neighbors found him.

The posthole digger was several years old and showed some wear. The tractor's PTO master shield was missing, but the shielding on the driveline from the tractor to the implement gearbox was in place, including the shielding for the connection where the driveline connects to the gearbox input

shaft. The connection under the gearbox where the gearbox output shaft attaches to the auger did not have guarding in place.

- Tractor operators should disengage drive elements and shutoff the tractor's engine before leaving the operator's station.
- Operators, and others, should stay clear when the posthole digger is in operation.
- Posthole auger drive elements should be guarded with all shielding in place and functional.
- Work areas should be clear of slip, trip, and fall hazards.

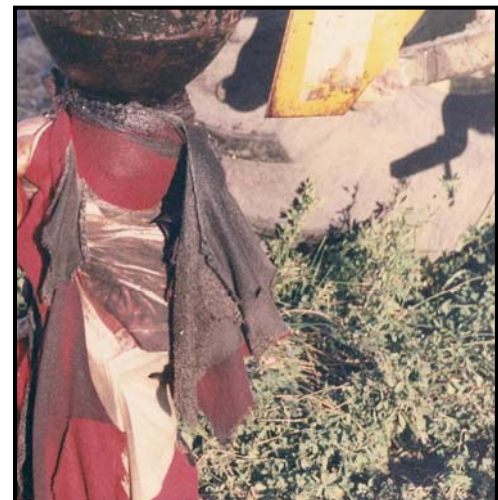
A bolt or shear pin is commonly used to connect the auger to the output shaft of the gearbox. A bolt or pin that is too long or has protrusions could snag clothing, and with the absence of guarding the potential for an entanglement in this area of the posthole auger increases. The victim was wearing jeans, sweatshirt, flannel shirt, and a t-shirt. Frayed or loose work clothes would be more susceptible to being snagged by moving machinery parts. Portions of the victim's clothing were entangled in the upper part of the rotating auger (Photo 2). His severed right arm was found near the posthole digger. His body was found about 30 feet (10 m) directly south from the rear of the tractor.

Photo 2 – Victim's clothing wrapped around the auger.

Recommendation #3 – *Posthole auger drive elements should be guarded with all shielding in place and functional.*

Operation of a posthole auger may require removal of dirt from around the hole so loose dirt does not fall back into the hole when the auger is lifted by the three-point hitch. Contact with moving machinery parts such as the auger, couplings, or driveline can lead to an entanglement, especially if guarding is missing, out of position, or not properly maintained. In this incident, there was no guarding around the coupling that connected the gearbox output shaft to the auger.
