FROM: Iowa FACE Case no.: 2011 IA 035 Report date: 10 October 2012

SUBJECT: Convenience store cook died from smoke inhalation

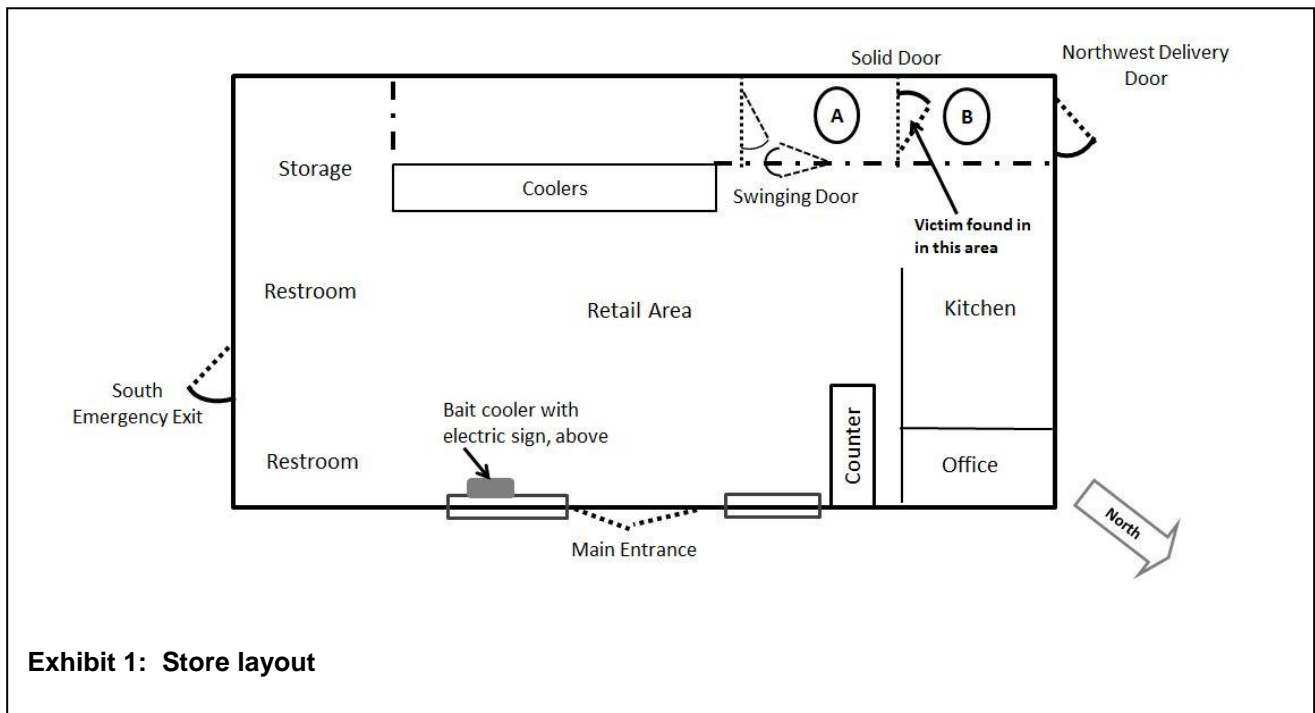
A 53-year-old convenience store cook arrived to work at 2:52 am to a closed and locked building to begin her shift. The building was a 2740 ft² structure with wood framing and steel construction. (An approximate layout of the store is provided in Exhibit 1.) Upon arriving to the store, the employee unlocked the front door, entered the building, and then relocked the front door from the inside with her keys. Lights to the kitchen and office areas were turned on to begin her shift, but the counter and retail area lights were shut off to prevent customers from thinking the store was open. The employee went to the office area to deposit her purse and keys and proceeded to the kitchen area to prepare donuts. The store was closed to the public as the worker began preparing donuts for customers for the upcoming day.

To the west of the kitchen area were the two storage rooms through which the worker would have to travel to escape through the northwest delivery door. The first room (“A” in Exhibit 1) contained a washer, dryer, hot water tank and extra soda from the store. To travel to the delivery door, one must pass through this room and through a heavy wooden door into a second storage area (“B” in Exhibit 1). This door was an outward-swinging push door (*i.e.*, swung toward the northwest exit) from room A to B, with a levered door handle, and hinges on the right of the door as exiting. This second room (B) contained a floor sink, buckets, electrical panel, the fire suppression system for the kitchen’s grill, and boxes of soda for the fountain dispenser. Employees reported that the door between these two rooms was usually shut.

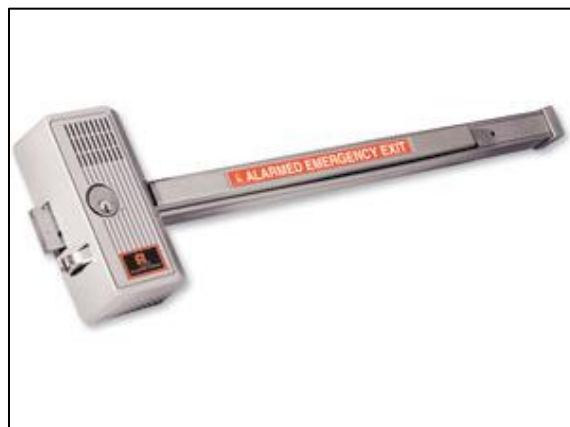
The employee remained on her cell phone with the 911 dispatcher, and when she was by the northwest delivery door, she indicated that it would not open. Exhibit 2 illustrates the type of panic bar installed on the door in question, although the door in this case did not contain the "Alarmed Emergency Exit" label on the panic bar itself. The installed panic bar had a keyed system to allow disabling the alarm system to facilitate moving product into the store during operating hours without activating an alarm. Once in storage room B, the decedent remained on the phone with the dispatcher until 4:04 am, when communications were lost.

Exhibit 2: Example of a panic bar ("crash bar") similar to the bar mounted on northwest delivery door

Although the northwest delivery door was not a designated fire exit, routine review and testing of the opening mechanism may have improved this worker's ability to escape. At this time, it is unknown whether the panic door mechanism had malfunctioned or whether the worker did not depress the panic bar on the northwest delivery door. Routine testing of the delivery door latch mechanism would have identified problems with the mechanism prior to the morning of the fire.

Substituting the interior-keyed deadbolt with panic bar hardware that locks to prevent entry from the outside, but allows exit from within would have allowed the worker to exit the door upon first detection of fire without having to find and insert her key. The employee could have potentially exited the store within seconds of detecting the fire. Alternatively, leaving the key in the lock until the store is opened may have assisted the escape of this worker, when visibility near the front door was limited by smoke that prevented her from approaching the door after locating her keys. The panic bar, however, is the preferred mechanism for fast escape.
