THE UNIVERSITY OF IOWA
Iowa City, Iowa 52242

Date of Report 11/15/1999

SUBJECT: Operator of three-wheeled agricultural sprayer was killed when machine overturned in steep ravine.

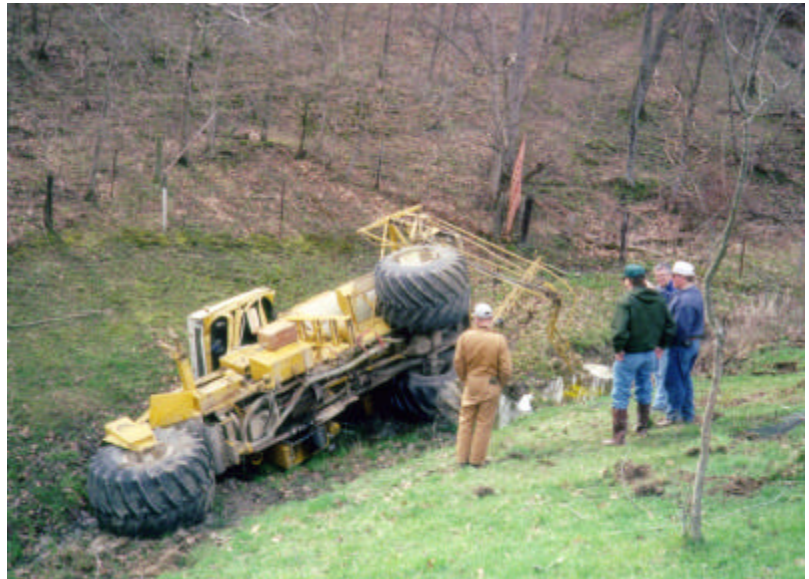
During the spring of 1999, a 26-year-old operator of a three-wheeled agricultural boom sprayer was killed when the sprayer drove through a barbed wire fence and careened down a steep ravine, rolling over at the bottom. The victim had just finished spraying a small 5-7 acre field with bean herbicide and was folding in the hydraulically-controlled spraying booms when the machine apparently moved forward too far and rolled through a barbed wire fence.

There were no apparent skid marks from braking. The ravine on the other side of the fence was quite steep and it would have been difficult to stop the machine once the front wheel broke through the fence. While running down the slope, the left rear tire of the sprayer hit a small tree, causing the machine to swing to the left, then crash on its side and top in the gully. The cab was not designed as a Roll Over Protective Structure (ROPS), nor were seat belts installed in this machine. Therefore there was little protection for the driver when the machine overturned. The operator was thrown through the front window and fatally crushed as the cab crumbled under the weight of the sprayer. The machine was 20 years old and appeared to be in good working order. There was some indication that the parking brake was not operational. We requested a test to determine whether the brakes were in working order, however the machine shop where the machine was taken after the crash was not able to have this testing done. The victim was an experienced sprayer operator. The injury occurred about 5:30 p.m. towards the end of the workday and fatigue may be a contributing factor. The death was not discovered until an hour later when the victim failed to show up at another work location. He was found dead at the scene.

The sprayer's left rear tire was flat when the machine was found, and tracks on the hillside indicate the machine hit a small 8-inch diameter tree with the left rear wheel. This swung the machine to the left causing it to crash on its right side and top. Had the sprayer not hit the tree, it may have crashed head-on into the opposite bank of the steep gully. The victim was partially thrown out of the front window and was crushed between the top of the cab and the dashboard area as the machine rolled over. The victim was last seen about 5:30 p.m. before he left to spray the field. When he did not appear at the next job, his father began a search for him and found the overturned sprayer after 8:00 p.m.

#1 Self-propelled agricultural boom sprayers should be equipped with Roll Over Protective Structures (ROPS) and seatbelts.

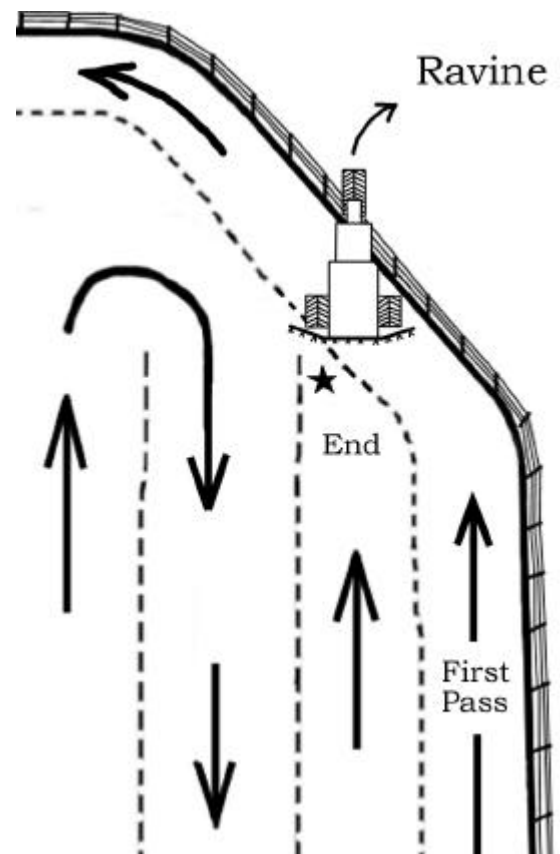
After spraying around the perimeter once and completing the back and forth spraying in east-west direction, the victim came to the southeast corner of the field, pointing towards the east. The last piece of ground to be sprayed was the pointed area marked with a star on the diagram. He had started to move the sprayer booms to transport position at this point. It is not clear whether he stopped or moved the booms while the machine was still in motion. The booms are at the back of the machine and pivot to the sides for transport. The width of the booms was 15.5 meters (51 feet) according to our measurement. It was apparent that the spray booms were partially folded in when the rollover occurred.

The end of the field was diagonal to the straight south edge of the field (see diagram). As illustrated in the diagram, to spray the entire area, the operator would have to drive forward into the perimeter strip that was sprayed, bringing the front of the machine very close to the fence. While coming to the end of the field and preparing to bring in the sprayer booms, it is possible that the operator could come too close to the edge of the field without noticing it in time.

Discussion: The field in this case was irregularly-shaped and the operator came to the corner of the field where the field edge turned about 45 degrees to the left. The operator had circled the field once at the perimeter and then had completed driving back and forth the rest of the field. As presented in diagram 1, to cover the area near the end of the diagonally edged field, the operator must drive very close to the edge of the field. If the operator makes two passes around the field before back and forth spraying, there would be more room at the end of the field to make turns and the stop at the end. This method may be safer in most cases when the field is irregular. Pesticide applicator certification training, as well as a company specific training should address this method.

#2 Agricultural chemical applicator training should include specific instructions regarding spraying irregularly-shaped fields.
