FROM: Iowa FACE Program

Date: August 2000

SUBJECT: Farmer crushed to death under broken corn planter.

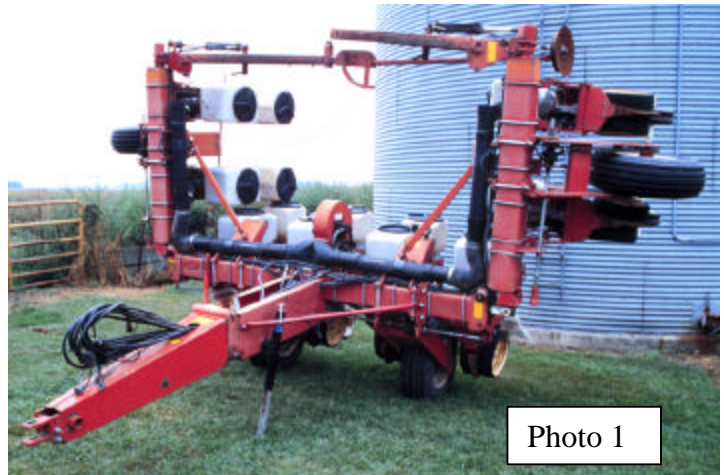
The victim and his father were working together on their first day of corn planting in the spring of 1999. The 8-row planter they were using was 10 years old and had been purchased four years earlier. The planter had a single axle and four wheels situated behind the toolbar (see Photo 1).

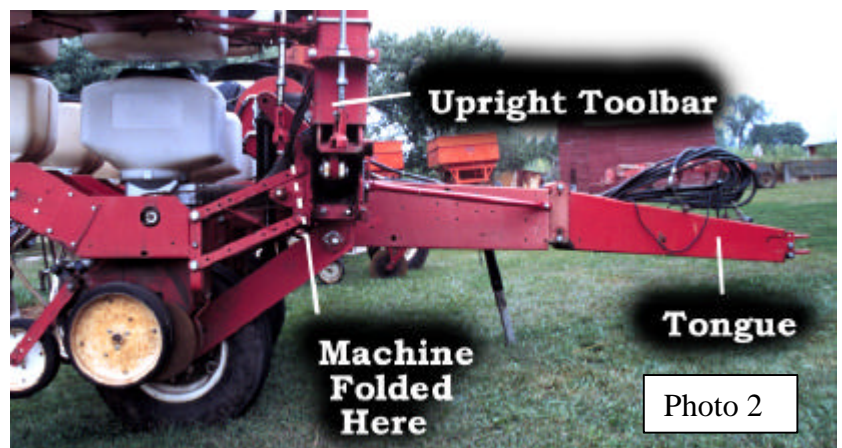
then suddenly without warning, the planter tongue folded in the region where it was attached to the toolbar (see Photo 2). What the victim was doing immediately prior to this is unknown. The toolbar with all its attachments, including the filled seed hoppers fell to the ground, crushing the farmer underneath. Rescue was called immediately, as the driveway was adjacent to the farmhouse, and the man was air-lifted to a regional hospital, however, his injuries were severe and he died shortly after arrival.

Discussion: Several identical planters from this manufacturer failed in the same fashion as this one, at the critical union of the tongue and toolbar. This design put too much stress on the bolts leading to bolt failure and breakage. Newer planters from this manufacturer have re-designed the union of tongue and toolbar, with welded seams that virtually eliminate a similar type of accident. If companies are aware of weaknesses in machinery design, they should warn current customers of potential problems while they are making design improvements.

Recommendation #1 *Owners / operators of farm equipment should never work under machines without appropriate support or bracing.*

Recommendation #2 *Manufacturers of farm equipment / implements should routinely review service calls for their machines and consider recalls or modifications as needed.*

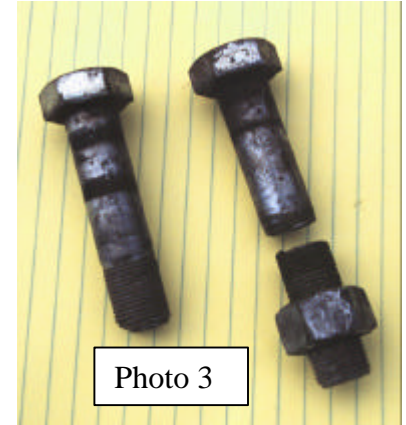
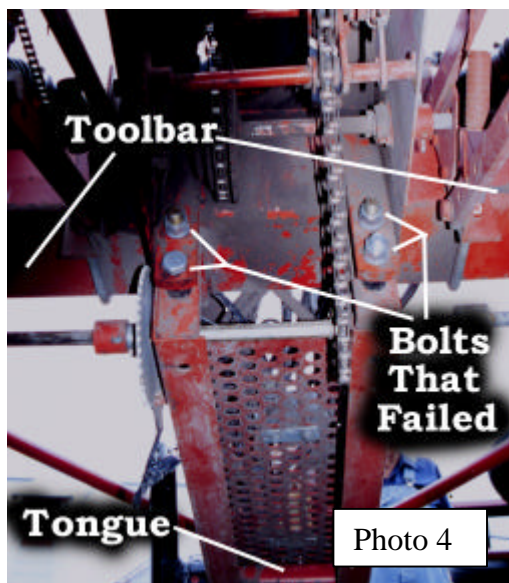
The tongue of this planter was bolted around the toolbar with six bolts, two ~ 250mm (10-inch) long bolts on top, and four 125 mm (5-inch) long bolts on the bottom, all of them being 19 mm (¾ inch) in diameter. It was the 125 mm (5-inch) bolts underneath the toolbar, which were broken. Portions of two of these bolts were retrieved from the field where the planter broke down, and we photographed these bolts during our investigation (see Photo 3). It appeared the bolts had been sheared off due to extreme forces acting on them during planting. One bolt had an obvious tear near its head, which was partially torn off.

We visited the local implement dealer who sold the used planter to the victim. Workers were aware of this fatality and stated that four similar planters had failed in the same manner that spring. They mentioned that it had been an unusually wet spring, and therefore the soil was hard and difficult to plant. They had repaired four similar planters, three with a missing or broken bolt, and another which had folded / collapsed in an identical fashion and hit the ground. We were told that the original specifications for the machine calls for 16 mm (5/8-inch) diameter bolts, but that they were recently upgraded to 19 mm (¾-inch) diameter, and that newer planters have a different design.

Mechanics at this implement dealership could see no reason why the planter needed to be bolted, rather than welded together at this stressful area under the toolbar. The section behind the toolbar rarely needed maintenance or repair and the components would be easily accessible even if the unit had been welded together.
