FROM: Iowa FACE Program

Submission Date: 1/12/2000

SUBJECT: Tractor operator was killed in an overturn while moving a sandblasting trailer.

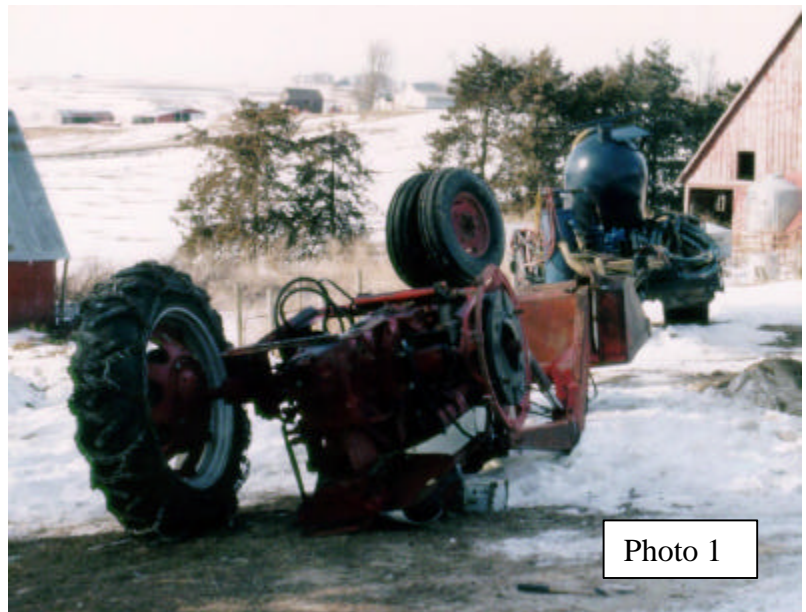
Photo 1

driveway. The trailer for the sandblaster had a high-mounted tongue, and the support jack for this trailer was in an extended position, therefore it was impossible to hook the trailer directly to the tractor draw bar. The man attached a chain from the trailer tongue to the front-end loader bucket. He lifted the tongue off the ground, then tried to back uphill with the tractor. The sand blasting trailer was full of sand and very heavy. It had snowed recently, and the victim was having difficulty getting sufficient traction while backing uphill in this position. Realizing he needed more pulling power, he attached a 50-foot chain from the tractor draw bar to the rear of a compressor truck used in the business. The man's wife drove the truck, following hand signals from her husband. The truck was positioned on the entrance road to the acreage, slightly at an angle from the tractor and the sandblasting trailer. As they began to pull and move ahead, the truck turned slightly to its right down the driveway. This created a situation where the chains were pulling the tractor at an angle creating sideways forces at both attachment points. These forces caused the tractor to overturn to its left side, killing the operator underneath. The tractor did not have a Roll Over Protective Structure (ROPS).

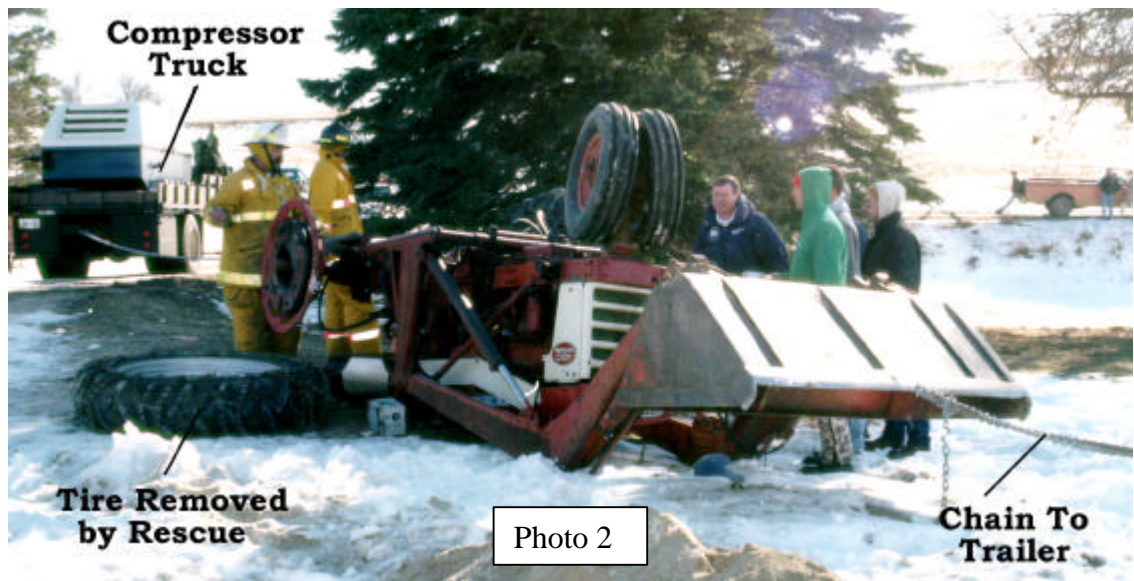
Discussion: Towing or pulling heavy equipment can become hazardous if the powered vehicle is pulling at an angle or if attachment points are high off the ground, thus increasing the risk of overturn. In this case the tractor front attachment point was the edge of the front-end loader (see Photo 2), which was approximately 1.2 m (4') off the ground. Supporting the heavy trailer with the loader shifted some weight from the back wheels to the front wheels, which reduced the tractor's pulling power and compromised stability due to the narrow front design. Initially the tractor and the sandblasting trailer were aligned, but after the truck started to pull and move down the driveway at an angle, significant sideways forces to the front and rear of the tractor were created. The combination of this changed angle, the tractor weight shifted to the front, the high front attachment point, narrow front wheels, and the sloping ground to the side of the tractor were accumulative factors sufficient to overturn the tractor to its left side. Even if visual communication between the two drivers was maintained, there would likely not have been sufficient time to react and prevent the sudden overturn. Pulling machinery at an angle should be avoided, and attachment points should be kept low, below or near axle level.

Recommendation #1 *To avoid overturns, operators of heavy equipment should pay special attention to the attachment points and direction of pull while towing other equipment.*

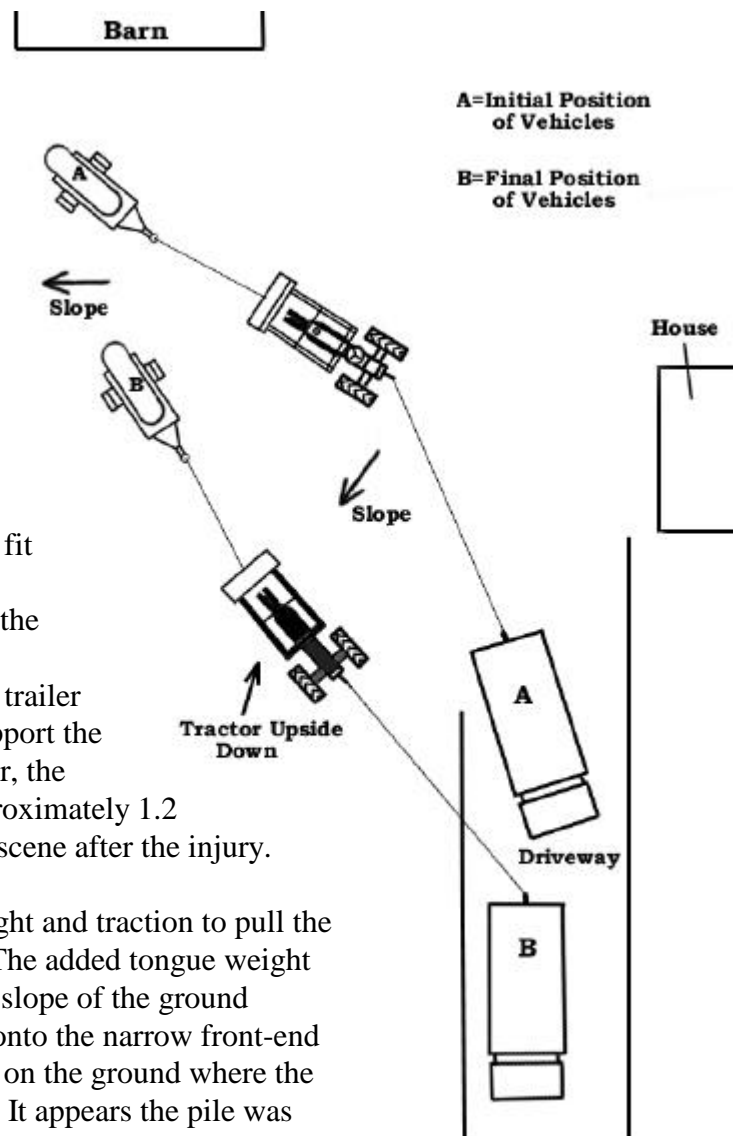
The tractor did not have sufficient weight and traction to pull the trailer up the slope on snowy ground. The added tongue weight to the front bucket, combined with the slope of the ground transferred weight off the rear wheels onto the narrow front-end of the tractor. There was a pile of sand on the ground where the tractor was sitting prior to the rollover. It appears the pile was formed from the rear wheels spinning backwards. Desiring more pull, the victim attached a 50-foot chain from the draw bar of the tractor to the rear of the compressor truck, which was positioned near the driveway heading towards the road. The tractor was an older tricycle-type model and did not have a ROPS to protect the operator.
