FROM: Iowa Fatality Assessment and Control Evaluation (FACE) Program

DATE: March 5, 1999

SUBJECT: Youth farm worker is killed when he becomes entangled in PTO driveline of an old grinder-mixer.

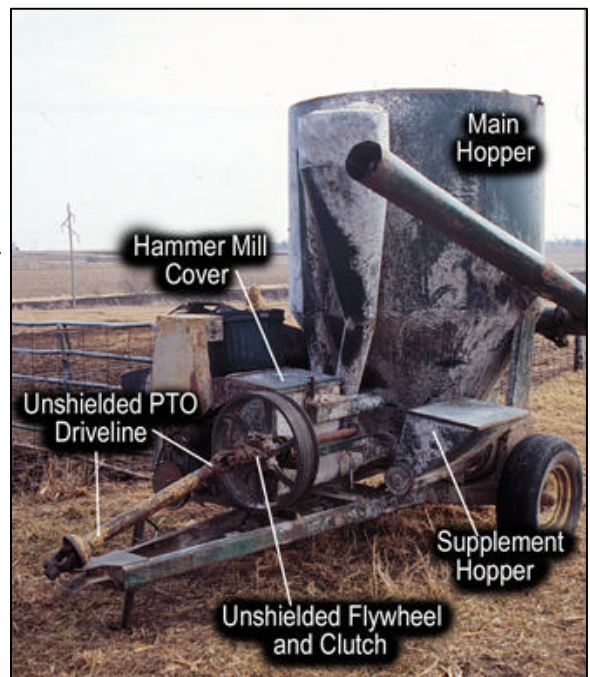
In January 1999, a 17-year-old high school student working part-time for a dairy farmer was killed when his clothing was caught by the unshielded power take-off (PTO) driveline of a grinder-mixer (see Picture 1). He had been helping the farmer add sacks of feed supplement to ground corn in the mixer. The task was almost complete and the farmer was closing the hammer mill cover while the youth stood near the PTO driveline in front of the flywheel. Although the flywheel was disengaged, the PTO driveline and unshielded flywheel clutch were rotating at about 200 revolutions per minute (RPM). The farmer heard a thump, then noticed that the boy had been caught and entangled around the driveline at the flywheel clutch. He died instantly from severe head injuries.

#1: ensure that PTO drivelines and other drive-line components are completely shielded to prevent worker contact with rotating machine parts.

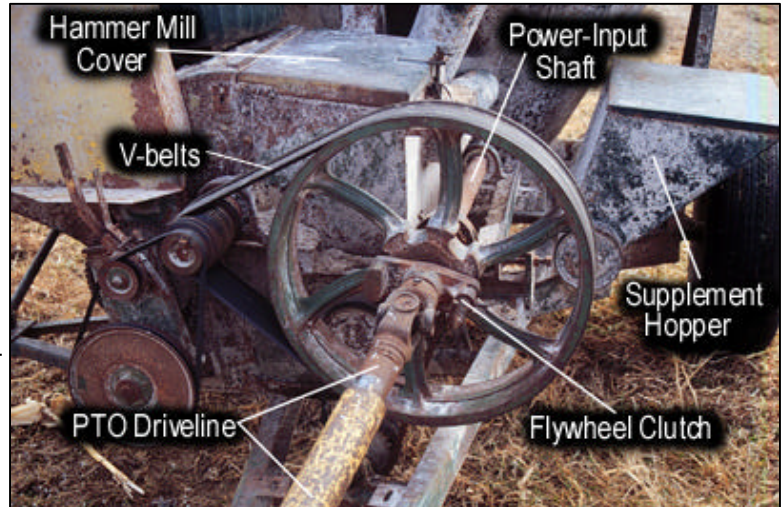
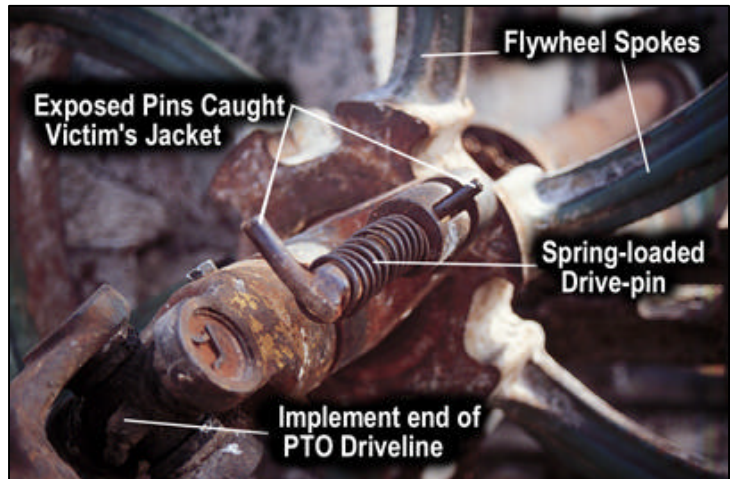
At the time of the injury, the farmer and the youth were mixing feed using the PTO-driven grinder-mixer to combine soybean-based protein supplement with ground corn. The grinder-mixer, a 1970's model, had been bought used in 1988. It was operated by a PTO driveline, which was permanently bolted to the grinder-mixer's power-input shaft (see Pictures 2 and 3).

The machine had two systems, grinding (milling), and mixing. To use the grinding system, one would engage the flywheel using the spring-loaded drive-pin of the flywheel clutch mounted on the power-input shaft (see Picture 2 and 3). The flywheel would then drive the hammer mill through a set of 12 V-belts. When disengaged, the flywheel floated (remained stationary) on the power-input shaft, while the clutch mechanism, including the spring-loaded drive-pin, rotated with the shaft. With the PTO engaged, the mixing system operated at all times. A feed supplement hopper (see Picture 2) was normally used for adding smaller quantities of feed supplements to the mix, however, the discharge auger for this hopper had not worked properly since the farmer had purchased the machine, despite efforts to repair it.

Since the supplement hopper did not work, an alternate method was devised to supply material to the mixing system. The hammer mill cover and a sizing screen were removed allowing feed supplement to be poured manually into the hammer mill housing. The hammer mill was not operated when this was done. However, a discharge auger at the bottom of the hammer mill housing was used to move the supplement to the main hopper where it was mixed with grain. The implement-end half of the driveline shield, as well as the shield covering the flywheel, had been damaged and removed by the farmer 10 years prior to the incident.

Recommendation #1: Employers should ensure that PTO drivelines and other drive-train components are completely shielded to prevent worker contact with rotating machine parts.

A total shielding system for a PTO driveline includes a tractor master shield, the PTO driveline shield(s) and an implement shield. Additional shields may be necessary to protect workers from exposure to other moving machine components such as flywheels, clutches, drive belts, and pulleys. For example, the power-input shaft was mounted on the left side of the hammer mill housing. Workers using the hammer mill for loading would be within only a few inches of this rotating shaft. Standards for drive train shields are contained in standards ASAE S318.13 and ASAE S522.

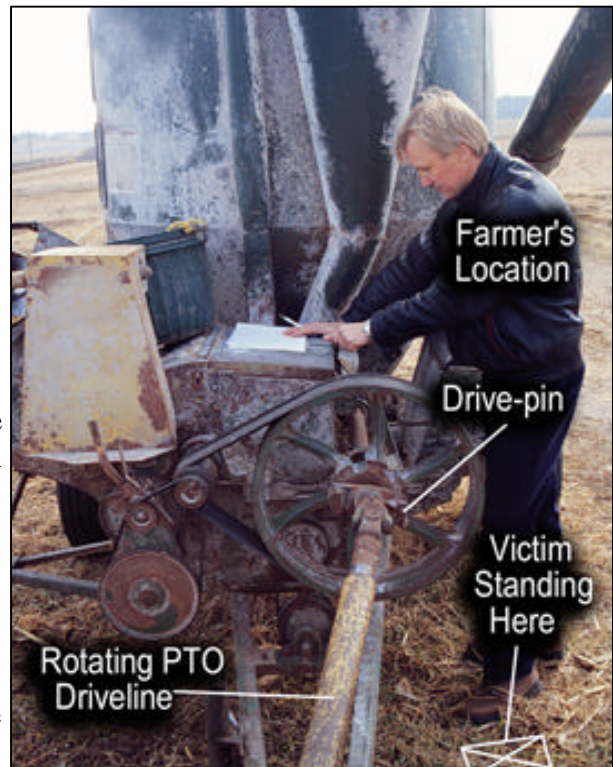
Since the grinding system was not being used, the flywheel was disengaged, however the unguarded clutch mechanism with exposed drive-pin was rotating. After the farmer and the youth had loaded about 25 sacks of supplement into the hammer mill housing, the farmer put the sizing screen back into a slot inside the hammer mill, then closed the hammer mill cover. The youth was standing on the farmer's left side (see Picture 4), facing the flywheel with his left side close to the spinning driveline. According to the farmer, while he was closing the cover, he suddenly

heard a thump, the tractor engine stalled, and he realized that the boy had been caught and wrapped around the driveline. Evidence indicated that the unguarded drive-pin caught the youth's jacket just below the left pocket and he was instantly entangled.

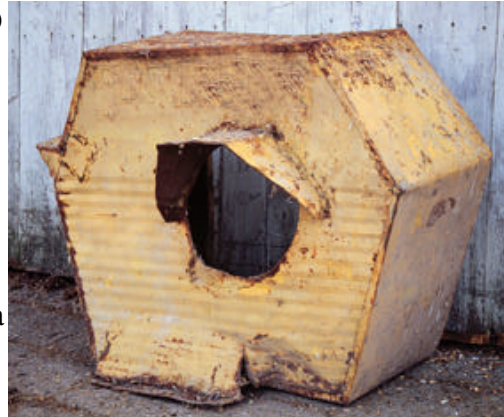
Discussion: The implement end of the PTO driveline, the flywheel clutch, and the flywheel on the machine in this incident were unshielded. The shield covering the implement end of the PTO driveline had been damaged and removed 10 years prior to the incident. The flywheel and the drive-train components at the front of the machine had originally been guarded with a sheet steel shield (see Picture 5). This shield had also been damaged and removed about 10 years prior to the incident. As previously stated, evidence indicates that the youth was standing near the rotating flywheel clutch facing the farmer when his clothing was caught by the exposed clutch mechanism, most likely the spring-loaded drive-pin. He was killed instantly when he became entangled in the PTO.
