**TO: Director, National Institute for Occupational Safety and Health**

**FROM: Iowa FACE Program**

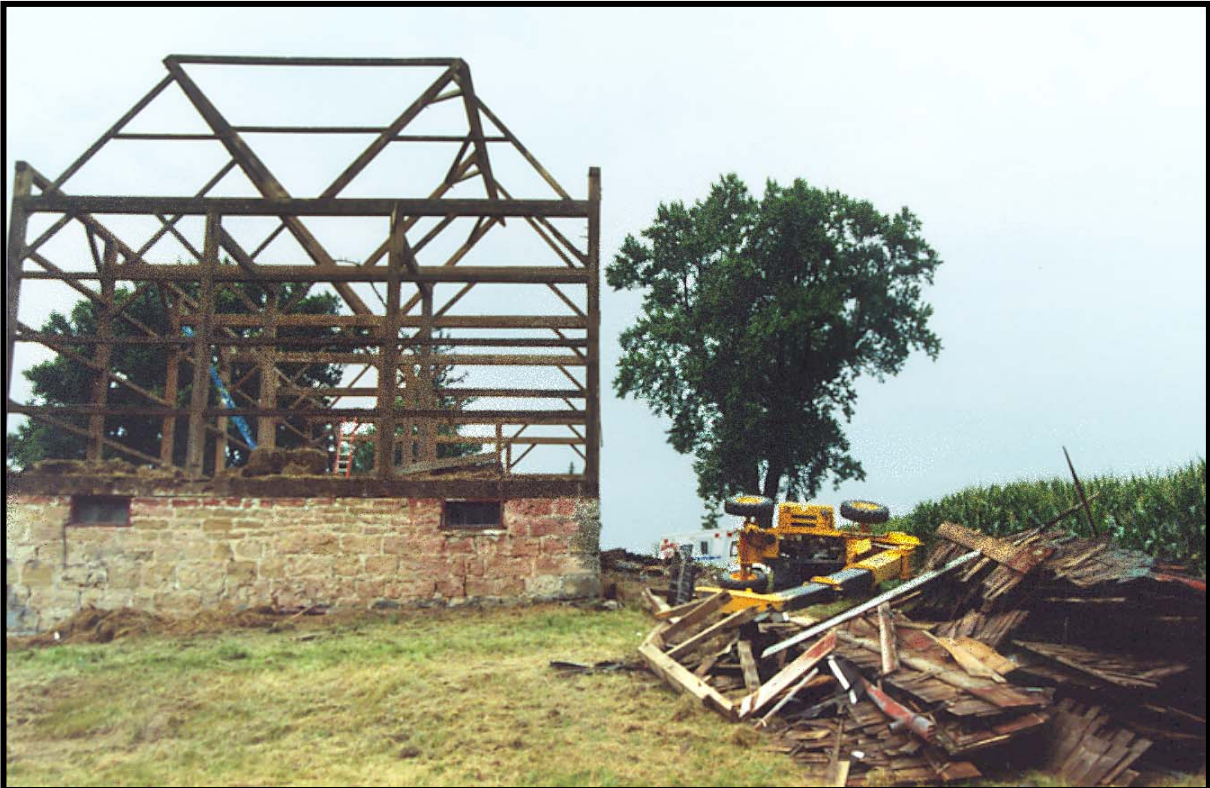
Photo 2 – View from the north side of the barn, showing the barn structure, the overturned forklift, and the broken rafter section lying next to the pile of discarded roofing.

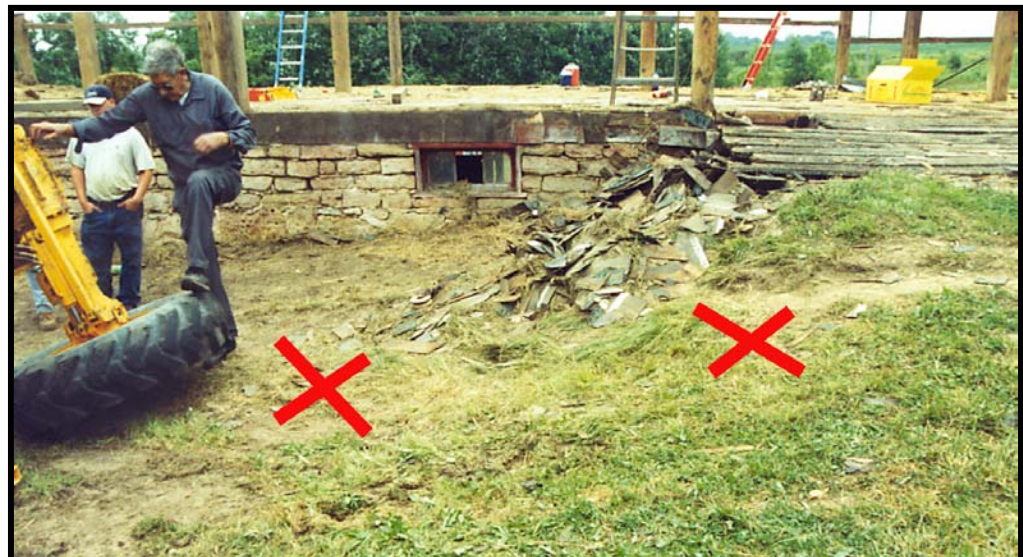
Photo 4 – View from the west of the barn, showing the approximate positions of the front wheels of the forklift, with the right wheel higher than the left due to the barn driveway.
