FROM: Iowa FACE Case No. 2004IA011 Report Date: 01 June 2005

SUBJECT: Mechanic Dies When Tractor Overturns While Removing Tree Stump in Cemetery

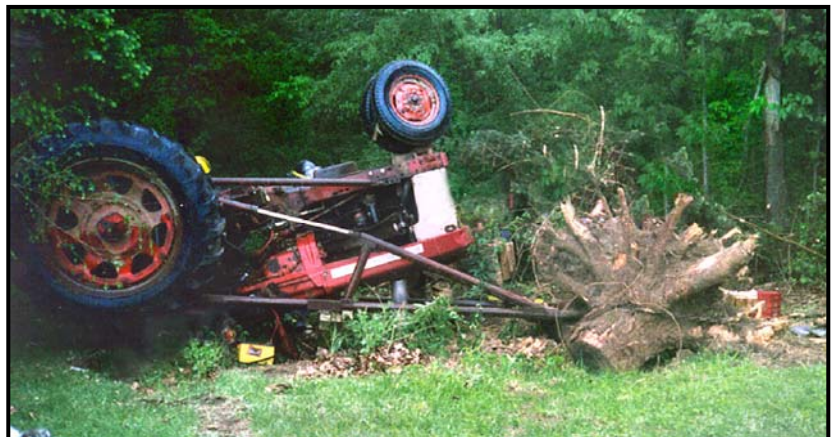
During the spring of 2004, a 36-year-old mechanic died in a tractor overturn. He was working alone in a cemetery picking up tree trimmings and removing a tree stump. He was using a narrow-front-axle (tricycle-type) farm tractor with a front-end loader. The loader was an older model with hydraulically-extendable lower links/lift arms to raise the loader bucket and its load (Photo 1).

Photo 1 – Side view of the overturned tractor showing the raised front-end loader with the stump secured by a log chain.

1. *Tractors suitable for the task, properly equipped with a rollover protective structure (ROPS) and seat belt, configured and ballasted appropriately, should be used with a capable, properly-installed front-end loader recommended for the tractor.*
2. *Operators should be educated and trained to recognize and assess the risk of an overturn and the factors that contribute to an overturn.*
3. *Workers should not operate tractors while under the influence of alcohol or when taking medications for which doctors advise against the operation of machinery.*

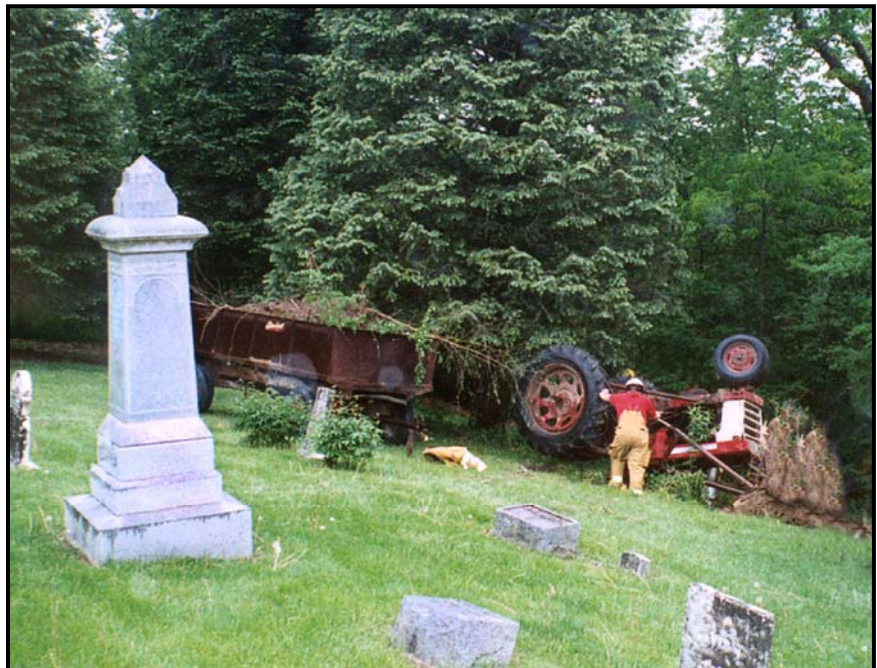
During the spring of 2004, a 36-year-old male part-time mechanic was killed in a tractor overturn. Iowa FACE personnel were alerted to this incident by a local newspaper article and began an investigation. Information was gathered from the County Sheriff, the State Medical Examiner, and the Clerk of the local township responsible for maintaining the cemetery (Photo 2).

Photo 2 – Overview of the cemetery showing the wagon load of branches and the degree of slope in the area.

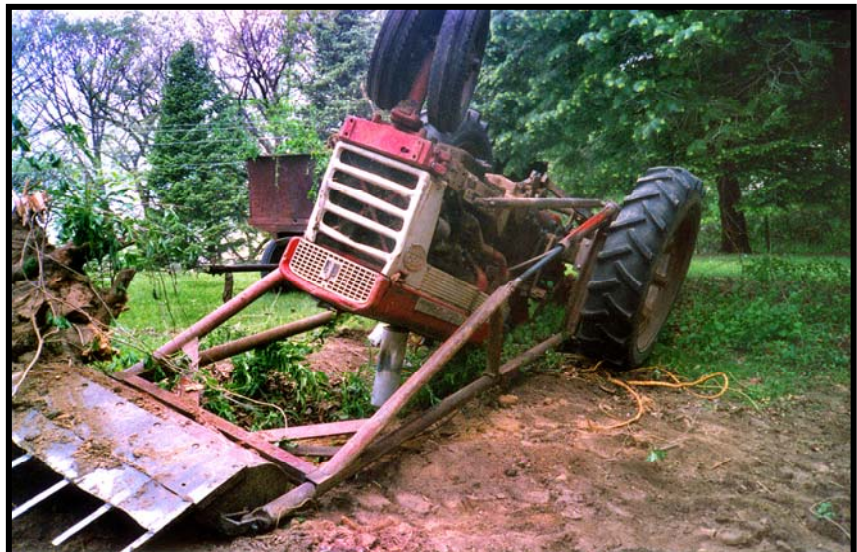
Photographs confirm the tractor had its front-end loader raised high (Photo 3) with the large stump reportedly tethered by a length of log chain secured around its bucket. The victim was apparently attempting to carry the stump and proceed to load it into the wagon nearby when the overturn occurred. The tractor-loader combination was aimed forward downhill in an area sloping downhill and to the left ahead of the tractor. Rescue workers found a bag containing several cans of beer, and postmortem tests results documented the victim's blood alcohol content (BAC) at 0.11%. This likely influenced his assessment of the overturn risk, including the equipment, operating, loading, and terrain factors contributing to it.

Photo 3 – Front view of the tractor, with the wagon uphill in the background, showing the front loader was raised prior to the overturn.
