**FROM: Iowa FACE Case No. 2005IA015**

**Report Date: 03 June 2010**

**SUBJECT: 84 year-old farmer died when tractor overturned while feeding cattle on hillside**

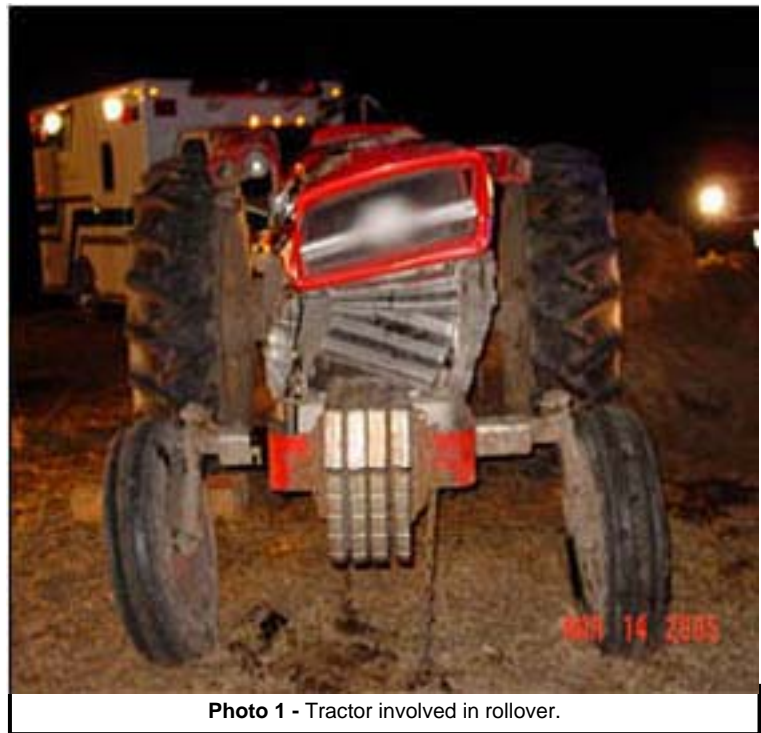
The victim owned and operated a 1966 tractor, which was never fitted with a rollover protective structure (ROPS). The tractor appeared to have three forward facing and one rear facing lights based on the sheriff photographs, but their operability and illumination capability were indeterminable following the incident. The tractor also had a tire that needed to be pumped up each day and a damaged right front wheel bearing.

Photo 1 - Tractor involved in rollover.

**Recommendation 1:** *Farmers should install rollover protective structures (ROPS) on tractors.*

**Discussion:** ROPS with seat belts are the most effective prevention strategy to reduce traumatic injury from overturns. ROPS are open heavy metal frames or frames within cabs that enclose tractor operators. They do not prevent tractor overturns but rather create a survivable environment around the operator. ROPS are available on newer tractors, but the decedent was driving an older one without a ROPS. Tractors can be retrofitted with ROPS and a seat belt at a reasonable cost, and programs that provide incentives to install and retrofit ROPS may be beneficial.

**Recommendation 2:** *Farmers should consider equipping tractors and other farm machinery used for operations between sunset and sunrise with additional lighting to improve the operator’s ability to identify hazards in low-light conditions.*

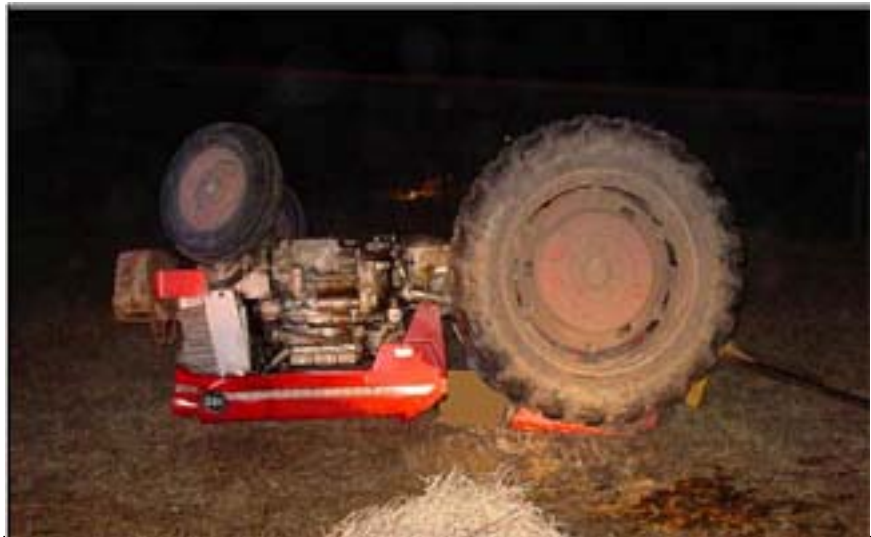
Tire track measurements suggest that the tractor was travelling down the hill at a fairly moderate speed in the wet terrain. Based on medical examiner investigations and an interview with family, two probable scenarios were offered to describe the incident. In one, the tractor appeared to have run over a large hay bale and overturned while traveling downhill. The tractor likely completed 1.5 full revolutions and stopped upside down, pinning the victim. Another scenario was that the victim had attempted a left turn to avoid the fence and ditch at the edge of the hillside, and that the sharp left turn along with the damaged right front wheel bearing and tire led to its instability. The tractor overturned on its right side and trapped the victim. Lack of artificial light and the speed of the tractor may also have been contributing factors.

The tractor reportedly passed through brush in a “reckless manner” prior to the overturn and may not have been under control of the operator.

Photo 2 - The final, inverted position of the tractor with pinned victim.

**Recommendation 3:** *Tractor operators should be educated to recognize and assess risk of an overturn and factors that contribute to an overturn. In particular, contributors to this incident were speed, tractor configuration, uneven surfaces, and wet conditions.*

**Discussion:** Tractors have relatively high centers of gravity compared to other vehicles, partially compensated for with longer and wider wheelbases. Steep, uneven surfaces can tip a tractor to the point where the center of gravity is no longer over the footprint provided by the wheels. Speeds should be reduced to accommodate wet conditions, which create less traction and longer braking conditions.
