FROM: Iowa FACE Program

Case No. 2005IA027

Report Date: 31 August 2006

SUBJECT: Farmer Killed When Raised Front-end Loader Bucket Attachment Falls

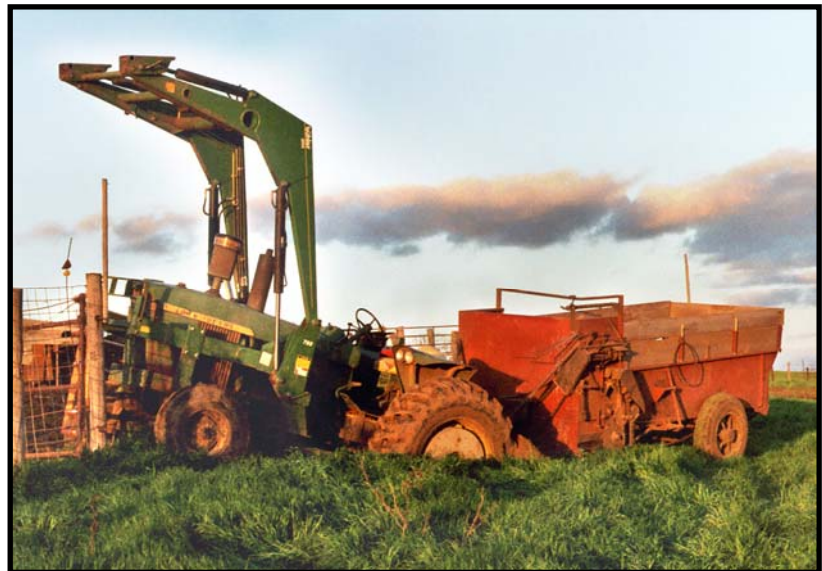
Photo 1 – Tractor and feed wagon where they were found (not where incident occurred) with loader still raised and tractor wheels dug deeply into the ground.

Investigation by law enforcement personnel at the scene found that the bucket attachment was not pinned to the loader's frame at the front of the lift arms (Photo 1). While moving uphill with the loader raised high, the bucket came free from its unsecured attachment. It fell to the rear, toward the operator's station, striking the operator on the head and chest. The tractor continued forward, struck a manure spreader, went through one fence and came to a stop against another fence. Its wheels continued to spin for several hours before the incident was discovered by the victim's wife.

Recommendation #1 – *A tractor with loader should be operated with the loader close to the ground as much as possible and have sufficient counterweights on the rear wheels, axle, or hitch for stability and traction.*

Discussion: Attaching a loader to a tractor moves the combined center of gravity forward. When the loader is lowered to where the center of gravity for it and the bucket is below that of the tractor alone, the combined center of gravity for the tractor-loader-bucket combination is lowered below that of the tractor alone. A lower center of gravity improves sideways stability. A center of gravity more forward reduces weight on the rear axle thereby reducing traction. In addition to improving stability, adding ballast weight to the rear wheels, axle, or hitch improves traction.

In this incident the weight of the loaded feed wagon's hitch on the drawbar of the tractor acted like ballast weight. After the feed was unloaded, the tractor had reduced traction which was evident when the farmer turned uphill to exit from the cattle yard. Having adequate counterweight installed could have provided sufficient traction to enable the tractor and grain cart to drive up the slope and out the gate.

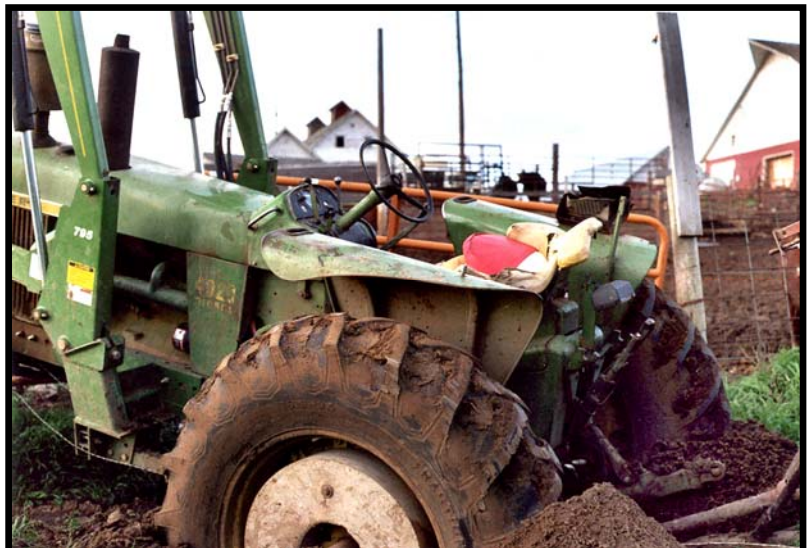
Photo 2 – Close-up of the tractor showing the rear wheels dug in, and also the smashed radio and damaged seat.

After several minutes she went to help and found him face down in the cattle yard with the tractor some distance away, against the fence, still running (Photo 2). She assumed he had been trampled by the cattle and ran to call 9-1-1. She also called a nearby neighbor.

The neighbor found the tractor against the fence along the south part of the cattle yard. The engine was still running. The wheels had dug in until the underside of the tractor rested on the ground and supported the tractor. The left wheel continued to spin in the dirt. When deputies arrived, they found the scene as described. They also found the bucket attachment for the loader at a separate location in the cattle yard, near the victim's cap which was buried in the muck by the manure spreader. After careful analysis of tractor tire tracks and other evidence, investigators were able to piece together an understanding of the sequence of events in this incident. Several findings confirm the sequence of events described above. Rubber tire marks were found on the bucket and corresponding fresh gouge marks were found on the tops of the fenders of the tractor. The radio on the right rear fender was smashed, and the tractor seat was also broken and bent backwards. These confirm that a very heavy metal object fell onto the rear of the tractor.

Recommendation #3 – *The loader should be lowered to the ground before exiting the operator station of the tractor and neither the loader nor the tractor should be operated from anywhere other than the operator station.*

Discussion: Away from the operator position, this farmer had diminished ability to control either the loader or the tractor. Controllable movements of either the loader or tractor could have contributed to the incident because they were not or could not be controlled because of where the operator was moving or because of where he moved.

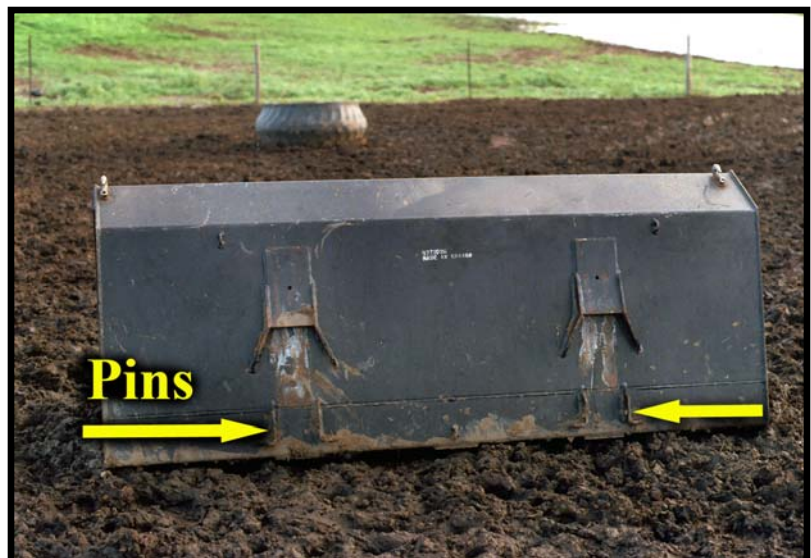
The bucket had a “quick attach” feature. Part of the connection requires inserting two locking pins to secure the bucket to the loader frame (Photo 3). These pins were not put in place, and with the combination of the raised loader and slope contributed to the bucket slipping off its mounting frame. The bucket fell on the victim as he stood on the hitch of the tractor then tumbled to one side. It struck his chest and head but he did not let go. The tractor moved forward up the incline. It collided with a manure spreader, which changed its course and knocked the victim off. The tractor then continued to the edge of the cattle yard where it crashed into the fence, made a U-turn, and then got stuck in the gate across the cattle yard with its wheels still turning.

Photo 3 – Loader bucket attachment shown with sleeves to capture the quick attach mounting members of the loader and showing the location of horizontal pins required to be put in place to secure the bucket to the loader during use.

At full height the bucket would be over 13 ft (4 m) above the ground. The ability of the bucket to “rollback”, to hinge around a horizontal axis, enables it to “cradle” material and keep it from spilling. Also at full height, full bucket “rollback” of typically 110 degrees (measured from where the bottom of the bucket is horizontal) means that the attaching mechanism would be oriented such that gravity

would no longer help hold the unsecured bucket on the mountings. It is not known why the bucket was not pinned in place. The pins for it were in the storage location on the loader lift arms.

Recommendation #2 – *Tractor operators should ensure that attachment locking devices are present, not worn excessively or damaged, function properly, and securely hold attachments in place during use.*

Discussion: The locking pins for this loader bucket quick attachment system were in their stowed location and not put in place to secure the bucket when it was installed. Some uses of the bucket will not demand the installation of the pins. Some operators may not take the time to dismount from the tractor to install them, especially for short term use situations. Nonetheless, it is essential that attachment locking devices be engaged when the attachment is installed.
