FROM: Iowa FACE Program

Case No.: 03IA27

SUBJECT: Anhydrous Ammonia Nurse Tank Rupture Kills Agricultural Cooperative Worker

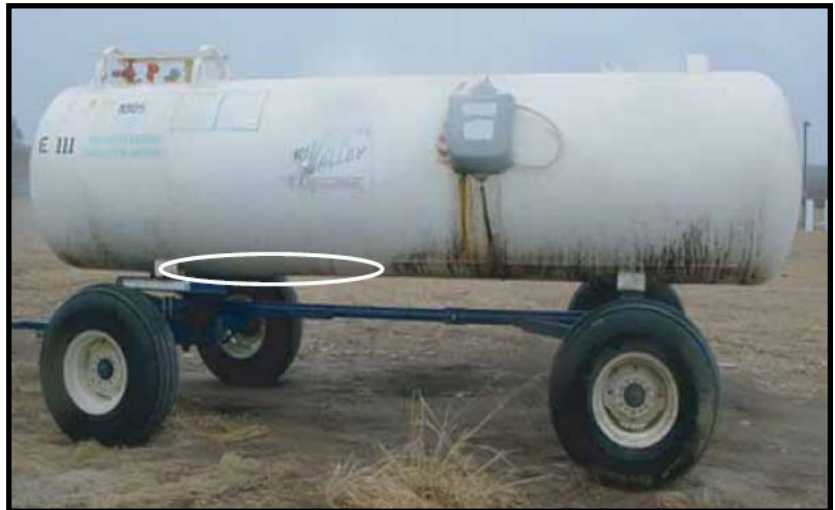
Photo 1 – The nurse tank with area of fracture site circled.
(Photograph courtesy of NTSB)

Abruptly and without forewarning, the nurse tank split open along a seam at the base of the cylinder near the front end. The pressure and rapid expansion of the escaping anhydrous ammonia created a very large, white, vapor cloud and several holes in the gravel lot underneath the ruptured nurse tank. The largest crater was roughly 7 ft (2 m) long, 5 ft (1.5 m) wide and 3 ft (0.9 m) deep. The explosion threw the coworker at the rear of the pickup truck against the pickup's back end and knocked him unconscious. The victim shut off the anhydrous ammonia transfer systems by activating an emergency shutoff switch located in the center of the nurse tank refilling station and went to aid the fallen coworker. The victim moved the unconscious coworker to the center of the nurse tank refilling station and placed him in the immersion tub. The victim then began rinsing himself and the coworker with the water in the immersion tub.

Recommendation #1: *Employers that operate liquefied anhydrous ammonia nurse tanks should institute periodic testing programs to ensure that the tanks are structurally sound.*

Discussion: Currently, neither the Department of Transportation nor OSHA requires periodic inspection and testing of nurse tanks. However, given the catastrophic results from the failure of one of these tanks, the National Transportation Safety Board recommended that periodic, non-destructive testing be conducted to identify material flaws that could develop during a tank's service life and result in tank failure. A template for inspection could be derived from the requirements for other cargo tanks that carry anhydrous ammonia. This inspection schedule is as follows: external visual inspection and leak testing annually, internal visual inspection and pressure testing every five years.

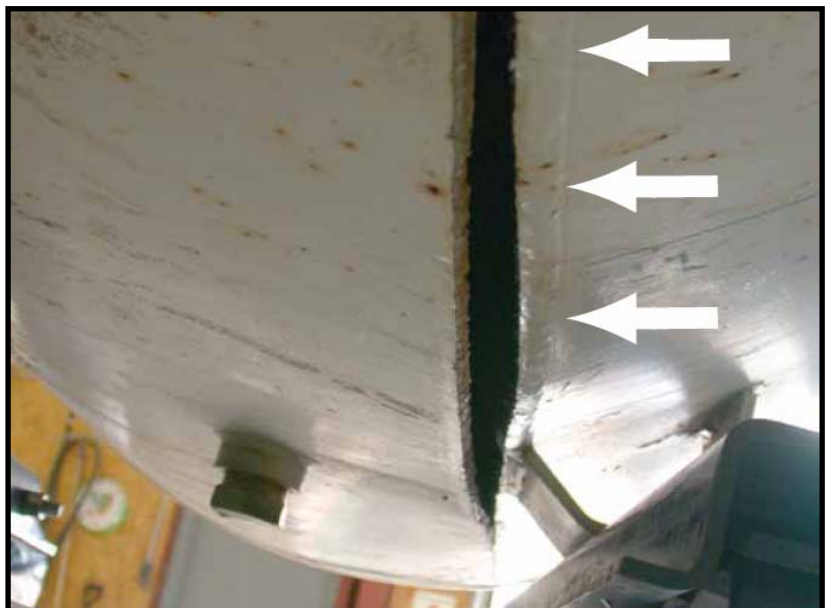
A nurse tank is a steel, cylindrical tank with hemispherical ends used for the transportation of anhydrous ammonia to farms where it is injected into the soil as fertilizer. Anhydrous ammonia is a gas at ambient temperature and atmospheric pressure, so it is compressed into a liquid state for transport. Because of the high pressures needed to maintain it as a liquid, it must be placed in specially designed tanks that can withstand internal pressures of at least 250 pounds per square inch (1.75 MPa). These tanks are formed by welding the seam of a steel plate that has been rolled into a cylinder. Steel hemispherical heads are then welded on each end of the cylinder to form the nurse tank. Subsequent investigation revealed that the rupture occurred in the weld seam of the cylinder behind the weld for the head end (Photo 2).

Photo 2 – The underside of the nurse tank with close-up view of fracture site. (Photograph courtesy of NTSB)
