Case No. 04IA60

Report Date: 8 June 2005

SUBJECT: 53-Year-Old Cattle Farmer Entangled in Exposed Rotating Conveyor Shaft

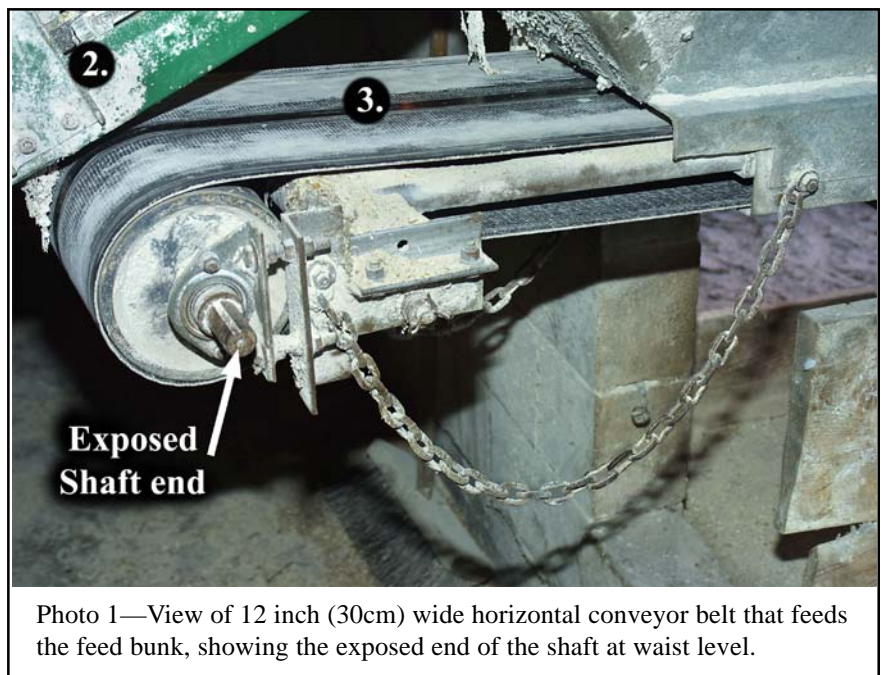
Photo 1—View of 12 inch (30cm) wide horizontal conveyor belt that feeds the feed bunk, showing the exposed end of the shaft at waist level.

foot (90 cm) clearance between the conveyor and the floor. The farmer was accustomed to ducking under the conveyor and had done so for many years. There were many unguarded moving parts in this work area. The shaft for the pulley at the end of the conveyor was too long, extending about 2.5 inches (6 cm) beyond the bearings on both sides of the pulley (Photo 1). The shaft had a keyway, which created sharp-cornered entanglement points on both ends of the shaft. The injury occurred while the farmer was ducking under the conveyor belt. His coat collar was caught and wound up in the exposed rotating shaft. He became entangled and the conveyor belt stalled as the coat wrapped around the shaft. He was found dead at the scene several hours later in the afternoon by a family friend.

Machinery and equipment must be guarded properly to avoid entanglements.

Discussion: Conveyors and feeding equipment have many moving and rotating parts. The farmer had to work in close proximity of the conveyor which had several entanglement points. There were many other unguarded belts, pulleys, shafts, and augers in the immediate work area. The end and bottom side of the main bunk conveyor was particularly exposed and the farmer had to duck under it through a three-foot (90cm) space

several times each day, in many cases when the conveyor was running. There are well established standards for agricultural machinery guarding which would apply for properly protecting moving parts in this work area (ANSI/ASAE S493).

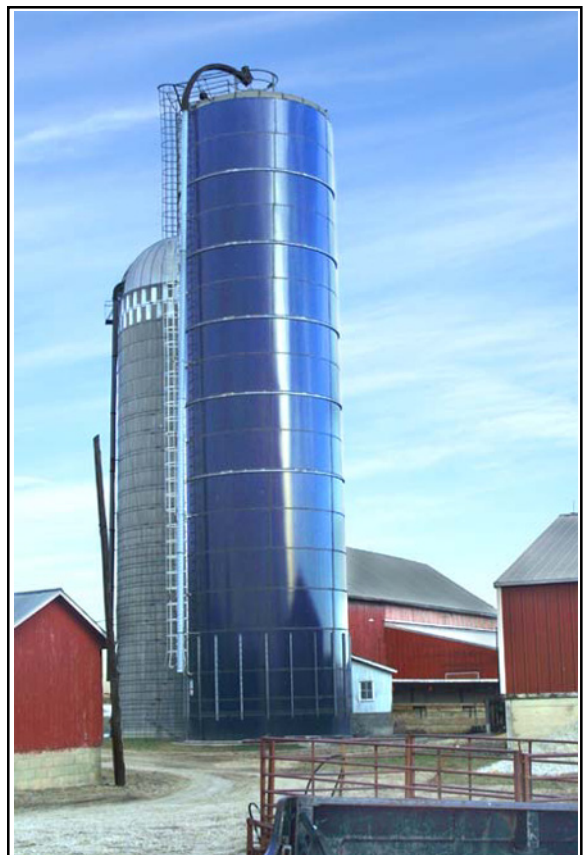
This cattle feeding operation had two silos as seen in photo 2. One was a conventional concrete silo and the other was a larger, oxygen-limiting silo. A feeding control shed was built between the silos from which feed was conveyed to the adjacent feed bunk that extended to the outdoor feedlot area. When the farm was a dairy, the concrete silo was filled with corn silage and the oxygen-limiting silo was filled with hay silage. Since the milk cows were sold 5-6 years ago, the concrete silo was abandoned, and the oxygen-limiting silo was used for ground, high-moisture ear corn. Between the two silos was a feeding control shed containing an auger and two conveyor belts, which were used daily to mix and distribute feed to the feed bunk (Photo 3).

Photo 2 – Outside view of silos showing the attached shed and adjoining feedlot.

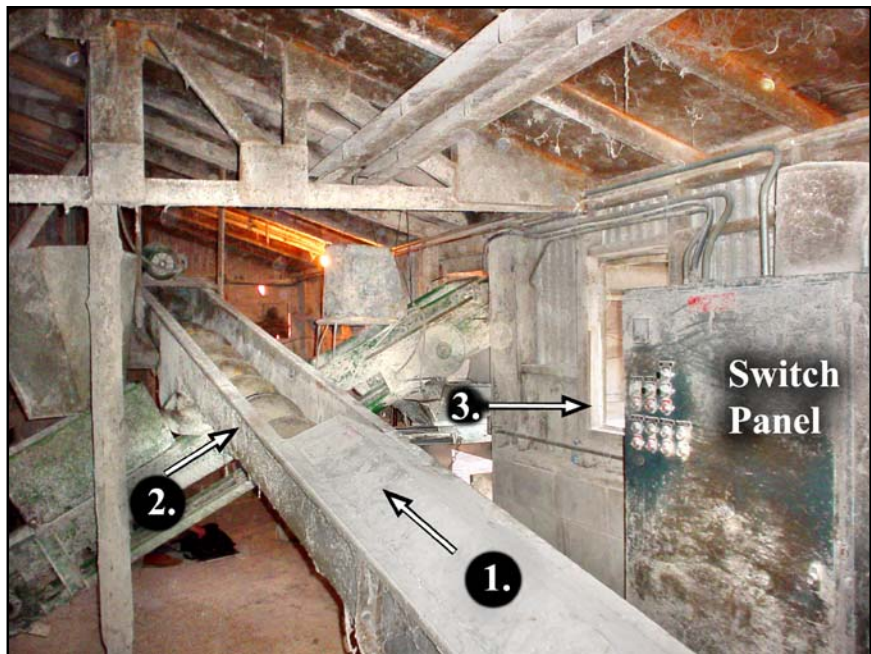
Photo 3 – View of the shed from the west end showing auger (1) bringing ground corn from the oxygen-limiting silo, conveyor (2) bringing silage from the concrete silo, and the horizontal conveyor belt (3) taking mixed feed to the feedlot on the right. The normal working position was to the left of the switch panel.

Discussion: The overall layout of the conveyors and augers in this feed shed created unsafe working conditions. The electrical controls for this feeding system were consolidated, but to access them the farmer often had to crawl under the main feed bunk conveyor. For mixing other feeds into the conveyor, he would have to go back to the other side again to manually move corn and/or other supplements to the conveyor. It is difficult to place conveyors, augers, and controls in a feeding system so that there is no need to work close to moving machine parts. However, with careful planning most hazardous work circumstances can be avoided.

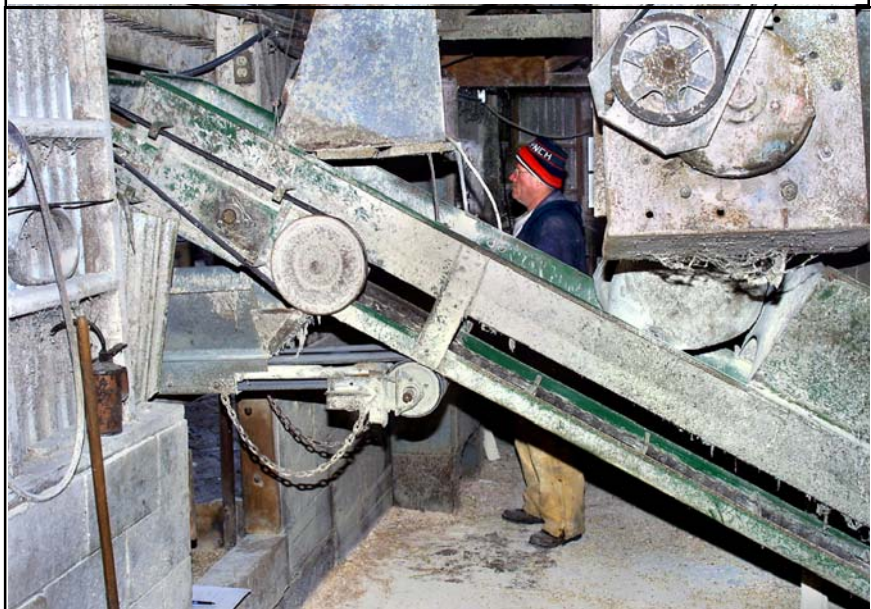
The farmer's normal feeding chores would take about 30 minutes early in the morning. As ground corn was moved from the silo by the auger, he would add cracked corn by bucket from a pile near the doorway of the shed. Photo 4 shows his normal work position at this time to the left of the switch panel. This task required the farmer to crawl under the exposed end of the horizontal conveyor belt a few times each day to access the switches, open and close the oxygen-limiting silo, and add corn to the feed. The farmer had become accustomed to doing this every day.

Photo 4 – View of conveyors from the doorway end of the shed, showing the farmer's normal work position, with the exposed ends of the horizontal conveyor at waist level.

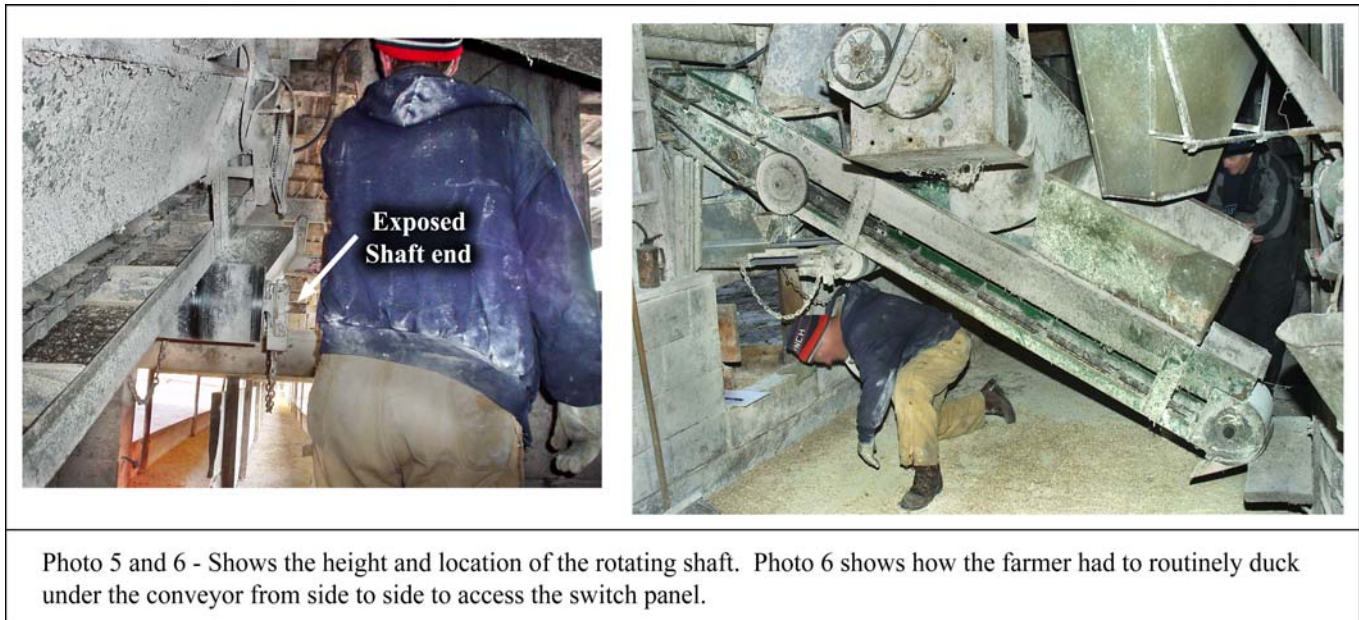
On the day of the incident, the farmer had gotten up early, about 4:30 am. He had been plowing all morning and proceeded to feed cattle about 10:30 am. During feeding, while ducking under the conveyor belt, the collar of his jacket was caught and wound up in the exposed end of the shaft for the horizontal feed bunk conveyor (Photo 5). He was strangled by his clothing and his entangled clothing stalled the conveyor belt.
