**FROM: Iowa FACE Program**

**Case No. 21A57**

**SUBJECT: Man Crushed Between Skid-Steer Loader and Dump Truck**

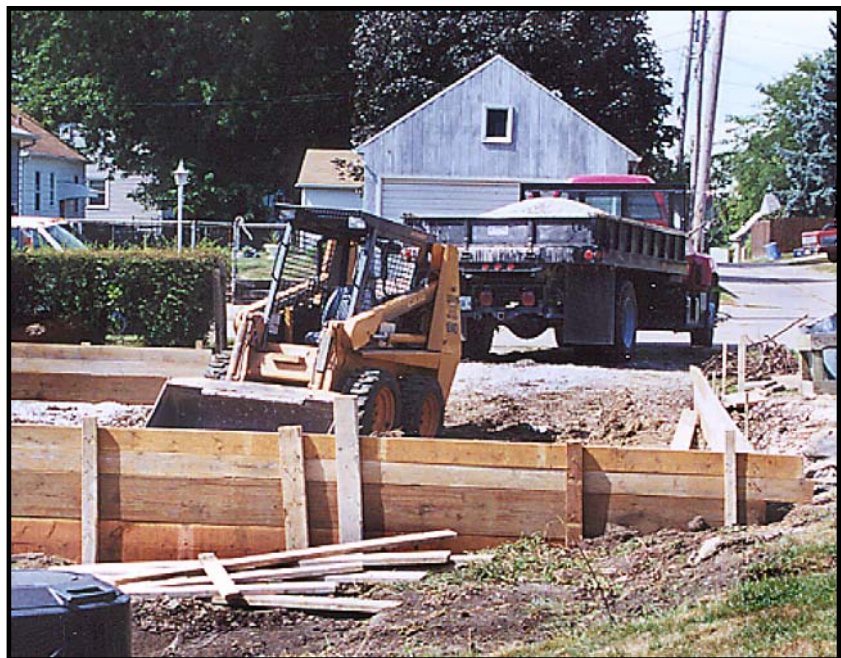
Photo 1 – View from front of skid-steer showing garage area and truck.

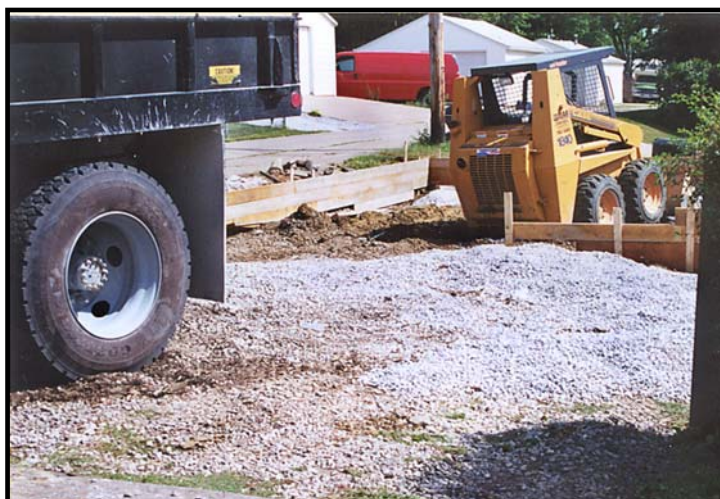
The concrete construction company was working to pour the foundation and floor for a new single-car garage in a residential neighborhood. It was their first day on this job and the crew was busy leveling and preparing the soil, setting forms, etc. One man was operating the skid-steer loader, moving dirt and gravel around the site with the back of the loader facing the street (vehicle access drive into the construction site). Other workers had just arrived driving a single axle dump truck with a fresh load of gravel (see Photo 2).

Photo 2 – View from sidewalk showing gravel pile and rear of skid-steer loader.

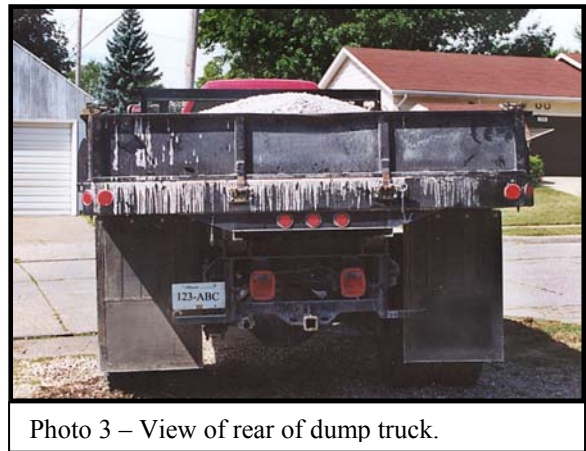
The victim, with his back to the loader, had just finished locking down the tailgate. His co-worker had finished doing the same on his side of the truck and had stepped to the side of the truck. At that time, while backing up, the skid-steer loader pinned the victim against the rear end of the dump truck causing fatal internal injuries. Only when he heard cries for help did the skid-steer loader operator realize he had backed into the victim, because the skid steer had not come into contact (collided) with the dump truck.

Photo 3 – View of rear of dump truck.

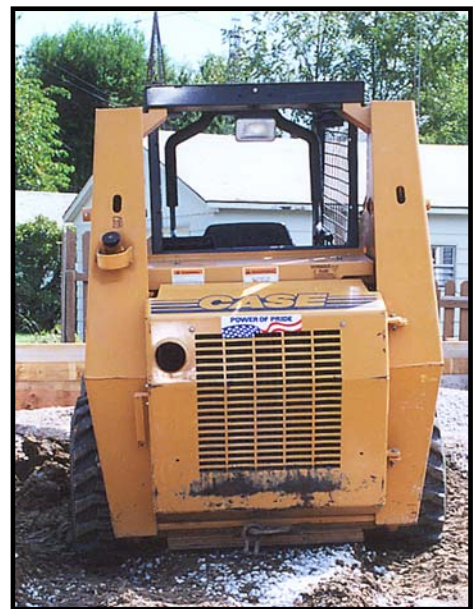
The skid-steer loader was a Case Model 1840 diesel, about 4-5 years old. It was in normal operating condition and did not have a backup alarm or rear view mirror. In the future, workers with this company agreed to never work directly behind an operating skid-steer loader. Further, all of these workers showed an increased awareness of the potential danger these machines present, and now give such equipment a much larger operating area.

Virtually all skid-steer loaders have inherent blind-spots to their rear due to their design and configuration. This makes the area to the rear of these machines an extremely hazardous place for workers. Backup alarms on loaders should be directed towards the rear of the machines to provide optimal reception by workers in these areas. Further, backup alarms should not produce pure tone sounds. Instead, the backup alarm should be at several different frequencies to prevent them from being canceled out by (indistinguishable from)

Photo 4 – View of rear of skid-steer.

**Recommendation #3** *Backup alarms with variable intensity and frequency should be installed on all skid-steer loaders, and owner / operators should ensure that mufflers are working properly to reduce machine noise*

**Discussion:** The use of a backup alarm is an obvious recommendation, however, alarms can easily become ineffective if they are ignored by workers or if their intensity is below that of the background noise level at a jobsite. As mentioned earlier, skid-steer loaders change directions very quickly, and an alarm which is constantly going on and off will soon become an annoyance, which may lead to its removal by workers.

other noise sources. Also, the intensity of backup alarms should be 10-15 dB above the surrounding background noise level.<sup>(1)</sup>
