FROM: Iowa FACE Program

Case No. 011A042

Report Date: 1-28-2003

SUBJECT: Tree Excavator Killed Using Skid-Steer Loader and Tree Shear Attachment

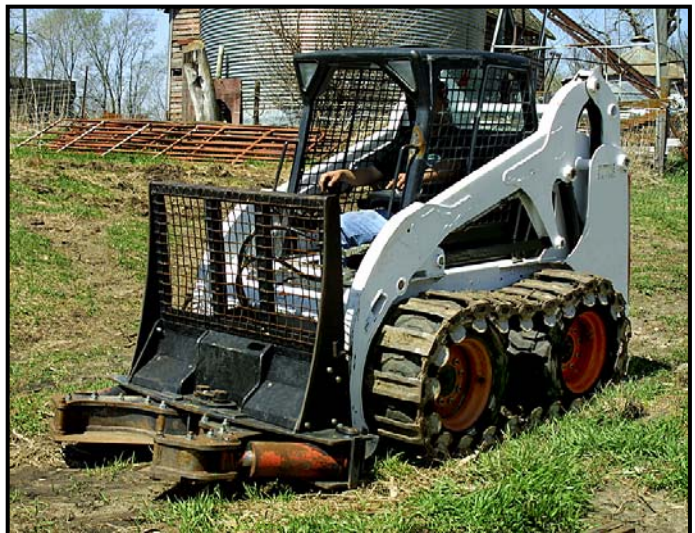
Photo 1 - Side / front view of loader with shear attachment.

There was no door or protective screen on the front of the skid-steer loader. A relative of the victim said the victim was planning to install one to provide protection from smaller branches. The tree shear had a 40-inch (1 m) tall heavy wire brush guard above the blades (see Photo 1). This guard separated the operator from the shear in normal operation, however, provided no

protection if the shear was raised several feet off the ground. In addition, when the shear was raised to a 3-4 foot (1-1.2 m) height, there was no visibility of the shear blades, and no way to observe the degree of penetration of the blades.

Considering the high likelihood of being hit by the tree or falling branches when cutting trees, it is important to have a protective cab totally surrounding the operator. Often skid-steer loaders have an open front area for easy access to the cab. In tree shear operation, the loader should have a protective door made of heavy metal screen or other durable material.

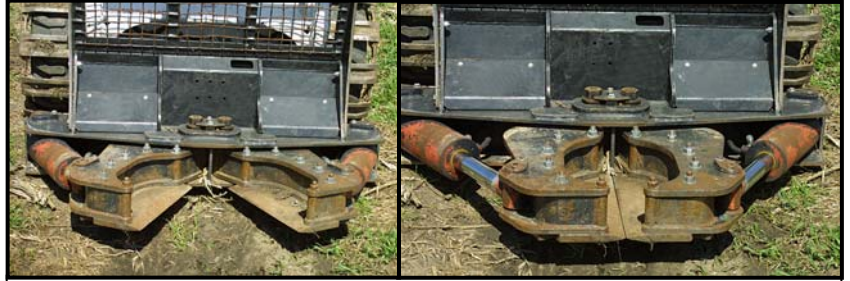
Photo 2 - Front close-up of tree shear in open and closed positions.

trees with a trunk diameter up to 14 inches (35 cm), the branches falling to the front or side of the loader. It was hydraulically-powered through a set of quick-coupling hydraulic lines. Two five-inch (125 mm) diameter hydraulic cylinders powered the heavy horizontally-opposed blades (see Photo 2). The blades were 20 $\frac{3}{8}$ inches (52 cm) long, and when fully open, measured 24.5 inches (61 cm) between their tips.

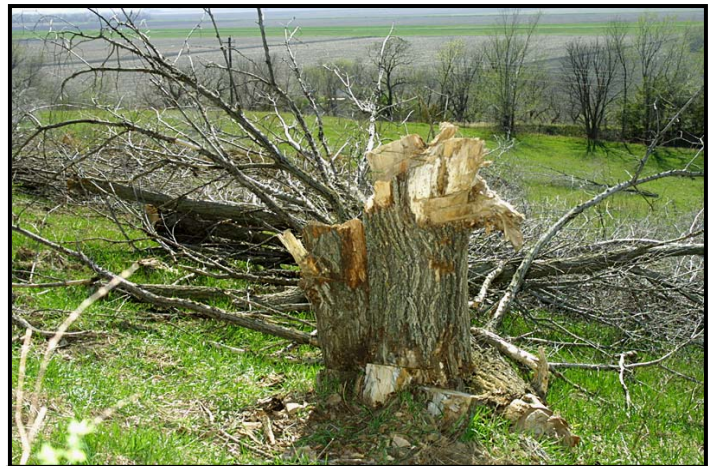
Photo 3 - View from uphill side of stump showing large limbs that had fallen downhill after cutting.

The tree stump being cut (see Photo 3) was about 28 inches (70 cm) in diameter at its base, which was much too large for the shear to handle. However, the tree branched out 3-4 feet (1-1.2 m) above ground into three smaller limbs, which the victim had been cutting prior to the incident. It was evident from track markings in the ground, and the cuts, that he had approached the tree from different angles to cut the left and right limbs. At the time of the incident he was positioned directly uphill from the stump for his last cut of the largest limb in the center, which

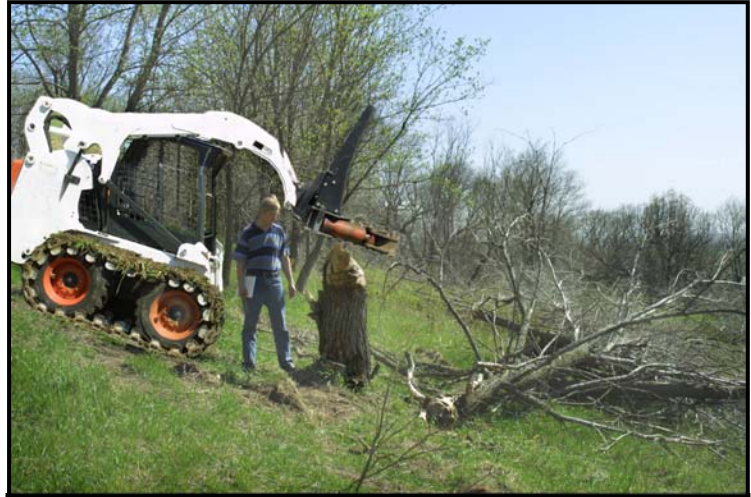
was about 12 inches (30 cm) in diameter (see Image 1). The shear blades were raised to the base of this limb, about 4 feet (1.2 m) off the ground. Apparently after he completed the cut, and while the large limb was falling to the left front of the loader, it transferred enough weight to the shear, that it tipped the loader forward onto its front wheels (see Image 2). The stump was immediately in front of the loader, and entered the cab area, pinning the operator to the back of his seat. The loader came to rest partially upside down, jammed onto the top of the stump. The frame of the cab was slightly bent by the tree stump, which just barely fit through the front opening of the cab.

Electronic Image 1 - Approximate position of loader and raised tree shear attachment, looking from the side. (see note below)

Note: The two electronic images on this page show the approximate position of the skid-steer loader before and after it tipped onto the tree stump. These composites were created from actual photographs of the loader and the stump, taken during the FACE site visit. Using photo-editing software, these images were combined to better illustrate the circumstances of this fatal event.

Discussion: Working on sloping or rough ground involves an obvious overturn hazard. Using the tree shear attachment in a raised position creates additional hazards. First, the attachment and the weight of the tree being cut raise the center of gravity of the skid-steer loader and make it more prone to overturn. Second, it is difficult to see the blades when the attachment is raised 3-4 feet (1–1.2 m), making it difficult and unsafe to operate. Third, the protective screen is above the shear blades, leaving no protective barrier under the attachment. In this case, since the shear was raised up, there was nothing between the operator and the fresh-cut stump. The operator's manual for this attachment did warn about using the shear attachment in a raised position and on slopes. These warnings should be emphasized in operator's manuals, perhaps with diagrams similar to Images 1 and 2. Furthermore, warning signs could be placed in a visible location on the tree shear attachment.

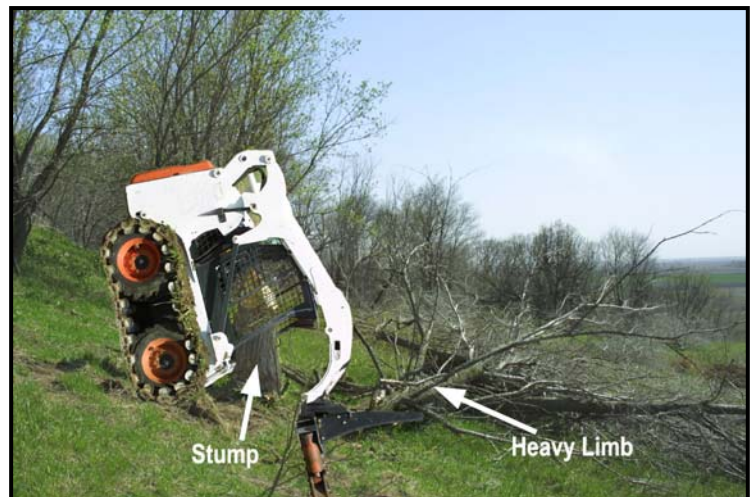
Electronic Image 2 - Approximate position of the loader after tipping forward onto the fresh stump. (see note below)

The operator's manual states this attachment is for ground use only, and that the lift arms of the loader should not be raised while making a cut. Using the tree shear attachment in a raised position created the hazardous opening under the loader attachment, large enough for the stump to fit through. When the loader is used near ground level, the operator is better protected. In case the machine would start tipping forward, the loader attachment itself would hit the ground and stop the machine from tipping. Also, the stumps would be shorter, unable to hurt the operator in a similar tipping situation.
