**Case No. 3IA60**

**SUBJECT: Farmer Crushed in Machine Shed Doorway While Using Skid-Steer Loader**

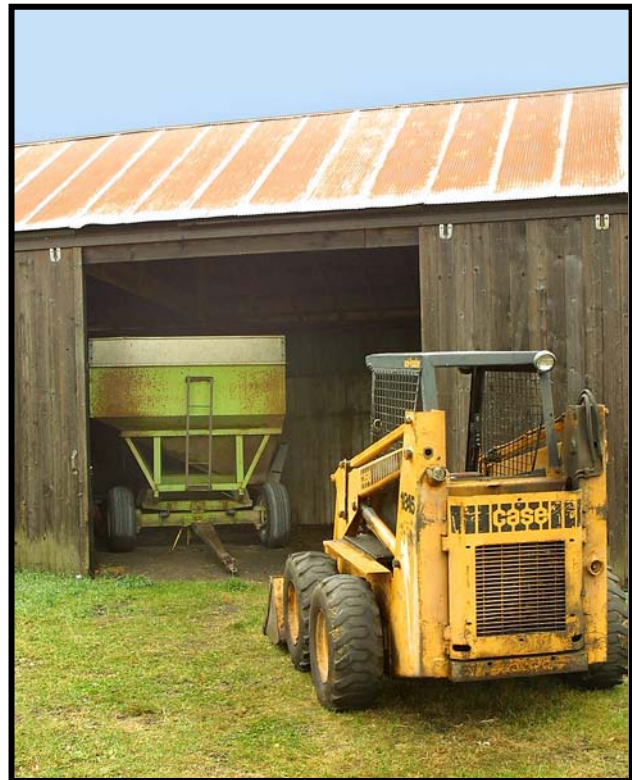
This was a routine task each fall, however, this time the farmer was fatally injured. He was found lying in the raised bucket, facing the rear of the machine, pinned against the header of the doorway shown in Photo 1. Besides crush injuries from the door frame, he also had a broken left ankle, which may not be consistent with this incident but may be from a separate injury event.

Photo 1 – View of the skid-steer loader, grain wagon, and machine shed (loader backed up six feet).

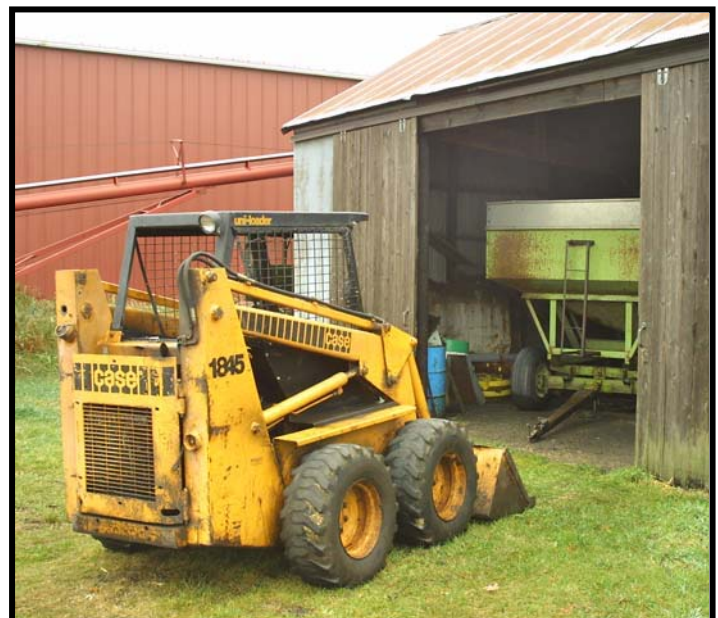
At the time of the incident, the skid-steer loader was approximately in the same position as shown in Photo 2, only 6 feet (1.8 m) more forward, with the bucket in front of the wagon in the doorway.

Photo 2 – Another view of the skid-steer loader, grain wagon, and machine shed

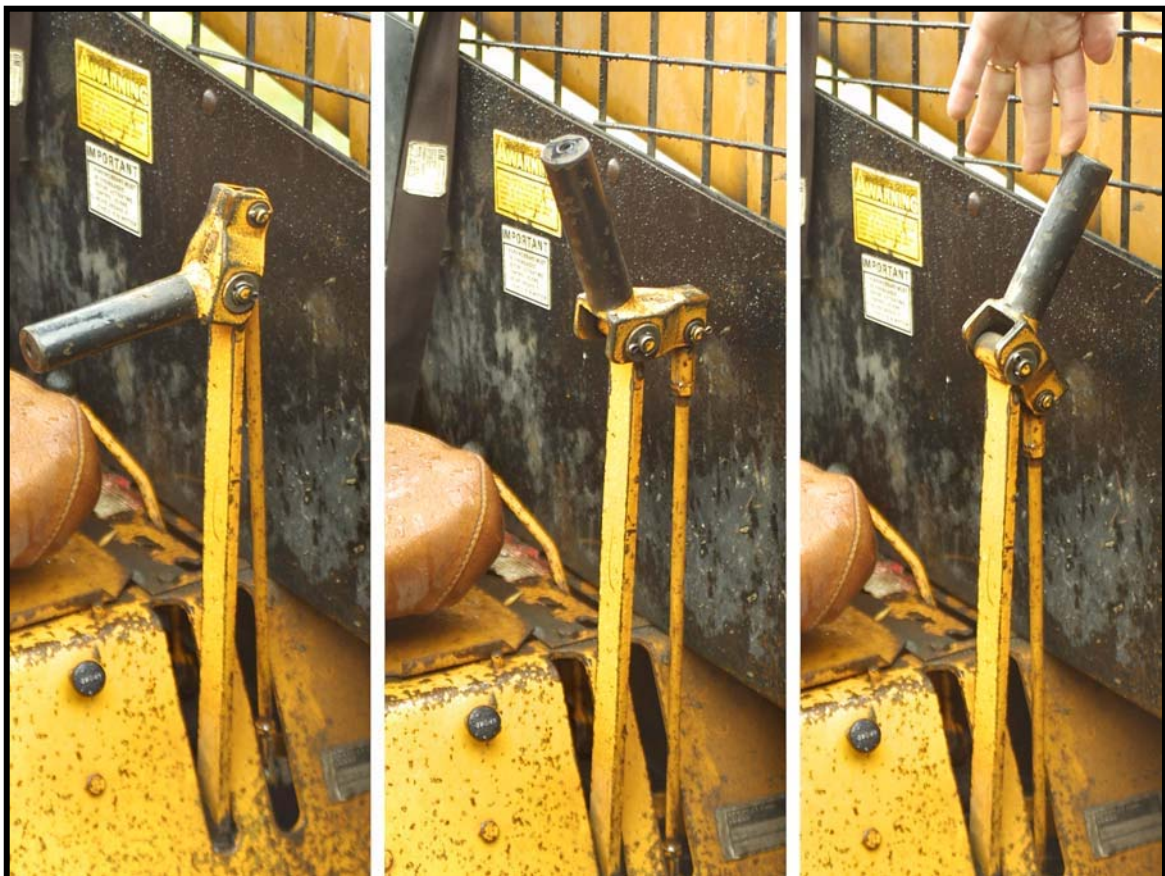
This skid steer loader did not have any foot pedals, but all movements were controlled by compound hand controls. Moving the control lever forward and backward controlled the wheels, while up and down motion of the hand levers controlled up and down movements of the lift arms and the bucket.

Photo 3 – Three images of the left hand control. The control handle in the FLOAT position (left) , the handle in NEUTRAL (center), and the handle held in the UP position (right).

Photo 3 shows the hand control for the left side wheels and lift arm height. The left image shows this control in the float position which relieves hydraulic pressure to the lift arm cylinders allowing the bucket to lower due to its own weight. The float position is used to allow the bucket to follow the contour of the surface on which it is sliding. Controlled lowering of the lift arms is accomplished by moving the control between the float and neutral position. The middle image shows the control in neutral position, and the right side image shows the control in the up position for raising the lift arms. The hand controls are designed to return to the neutral position by centering springs inside the machine. During our investigation, which was with the engine not running, we noticed that the controls had significant wear and stickiness. Due to this wear, stickiness, and/or weak centering springs, the right (bucket) control handle would stick in the up position, but the left (lift arm) control handle would return to neutral. The machine was not operable at the time of our investigation, so it wasn't clear if the hand controls or the hydraulic valves were also sticking when activated with the engine running. One of these malfunctions was necessary for this incident to occur, for the bucket continued rising, even when the victim could not have reached the control.

**Discussion:** This older skid-steer had wear from previous use. The control linkages were worn and in need of adjustment and repair. The left side control for the lift arms did not return to the neutral position as designed. After it was activated, the loader kept rising which could have been caused by a sticky linkage or hydraulic valve. The centering spring in the valve assembly is an important safety feature in the control system and should be maintained to assure controls function properly.
