**FROM:** Iowa FACE                      Case No. 2005IA020                      Report Date: 30 December 2008

**SUBJECT:** Farmer engulfed and suffocated in soybeans during unloading of steel grain bin

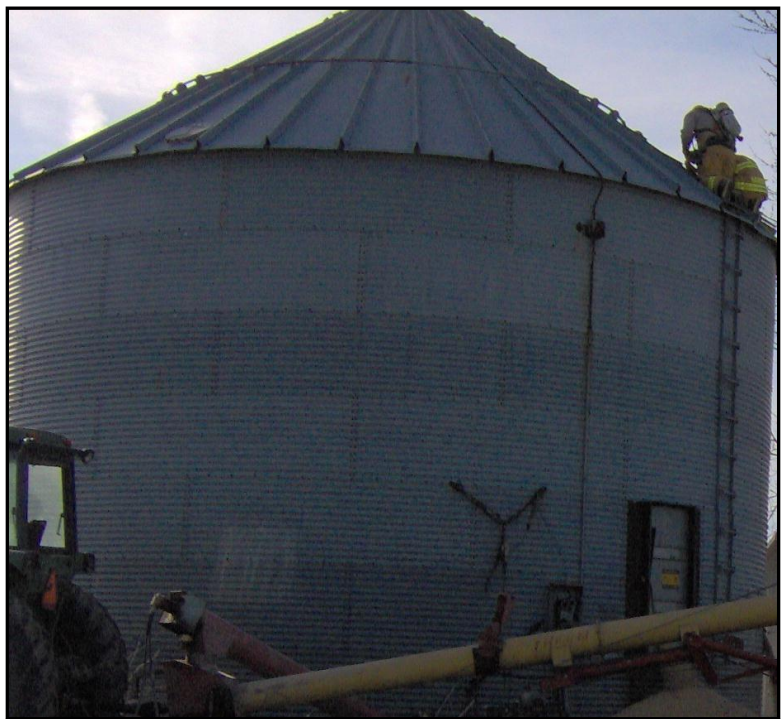
The bin (Photo 1), formed by sections of corrugated steel bolted end-to-end in rings placed one on top of another, was 30 ft (9.1 m) in diameter and 7-rings high, about 18 feet (5.5 m) to the edge of its cone-shaped roof. It had a capacity of ten thousand bushels (350 cubic meters) and was three-quarters full at the time of the incident.

The Deputy climbed the ladder on the outside of the bin to the top entry hatch in the bin's roof and looked inside. He saw impressions in the surface of the soybeans that appeared as though someone had walked to the middle of the bin, the area over the intake opening for the auger, perhaps to remedy a plug or retrieve a clump of crusted beans.

**Photo 1** – Rescue workers on top of bin assessing situation through entrance hatch of grain bin.

Cylindrical, flat-bottomed grain bins like the one in this incident empty out the center of the bin floor. Grain flowing toward the center and then down to the floor forms a column of moving grain. That column of moving grain can engulf a person like quicksand, making escape impossible in seconds and submerging a person in less than a minute. This can occur suddenly, especially with modern, high-capacity unloading augers running underneath. Convinced the farmer had walked to the middle of the bin and become trapped in the flowing soybeans, rescue personnel, family members and neighbors used torches to cut openings in the steel rings and worked to empty the bin as fast as possible in an intense hour-long rescue attempt before the farmer's body was found.
