FROM: Iowa FACE Program

Case No. 2IA3

SUBJECT: Construction Worker Killed When Cement Forms Fell From Crane

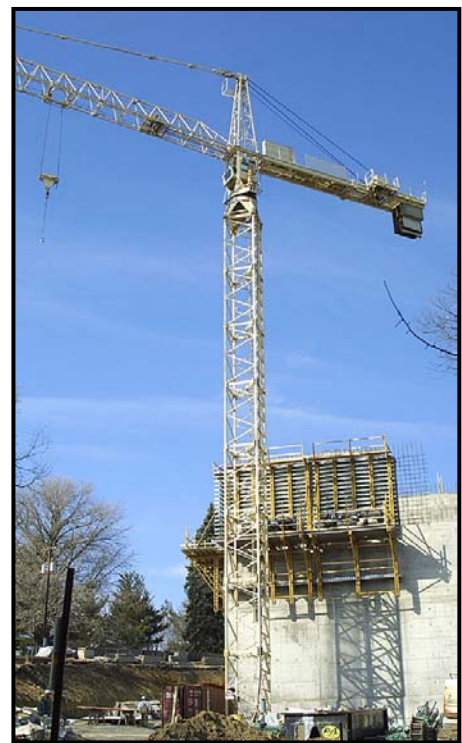
Photo 1 -- Hammerhead crane at site.

The electric powered hammerhead crane was erected near the southwest corner of the building, and provided full access to all areas under construction. This crane was 120 feet tall (36 m), with a reach of 180 feet (55 m), and a capacity of six tons (5.5 metric tons) at full extension. On a busy day, the crane was in constant use, making a lift about every 10 minutes, transporting all types of building materials -- brick, mortar, lumber, re-bar, steel, etc. On the day of our visit, the

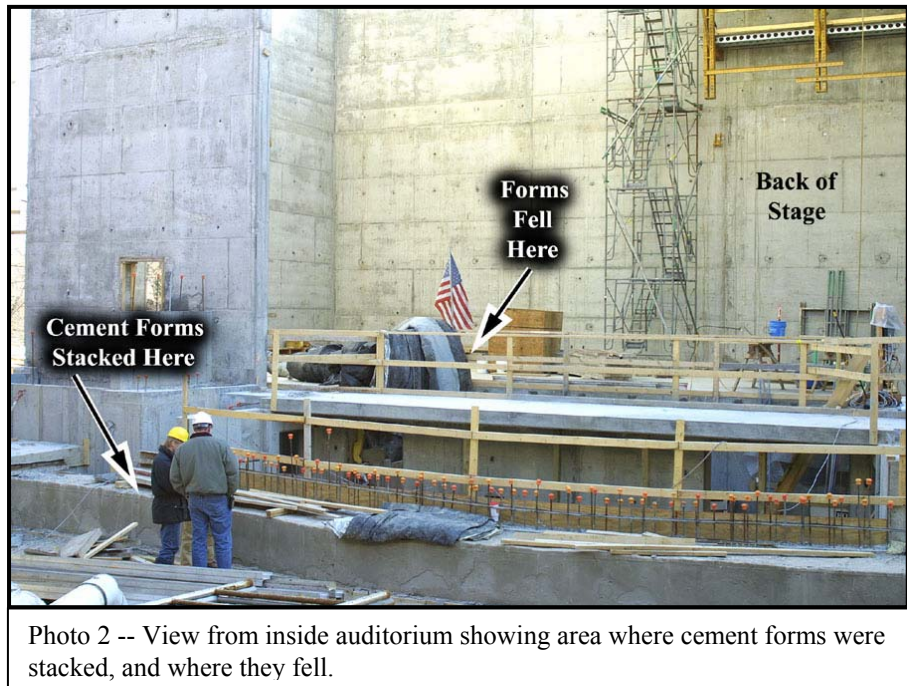
The construction crew was building a new auditorium for a private college, and had been pouring multiple concrete foundations and walls. The victim was working that day as the ground man, supplying other co-workers on a platform in the stage area of the auditorium (see Photo 2). There was no special reason he had to be in the area where the load fell, and exactly what he was doing at that time is unknown.

Photo 2 -- View from inside auditorium showing area where cement forms were stacked, and where they fell.

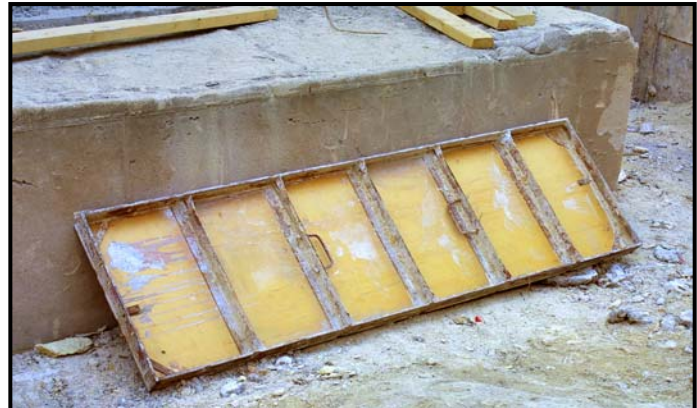
The cement forms were of various sizes, and consisted of plywood sheets attached to a steel frame (see Photo 3). Most of them were 24 inches (60 cm) wide, and four, six, or eight feet (1.2, 1.8 or 2.4 m) long. These forms were used for interior walls, and not for exterior load-bearing walls. They were stacked inside the auditorium, out-of-sight from the crane operator's station, due to an auditorium wall, which had previously been built (see Photo 6). The forms were stacked flat, with the two nylon slings arranged at appropriate locations to ensure a balanced load. On end view, the stack of forms was approximately 24 inches (60 cm) wide and 33 inches (84 cm) tall. The heavy-duty two-ply slings were four inches (10 cm) wide and 16 feet (4.8 m) long, with a choker capacity of 8,600 lbs. (3,900 kg) each. The slings were fairly new, being in service only a few weeks.

Photo 3 -- Typical plywood and steel cement form.

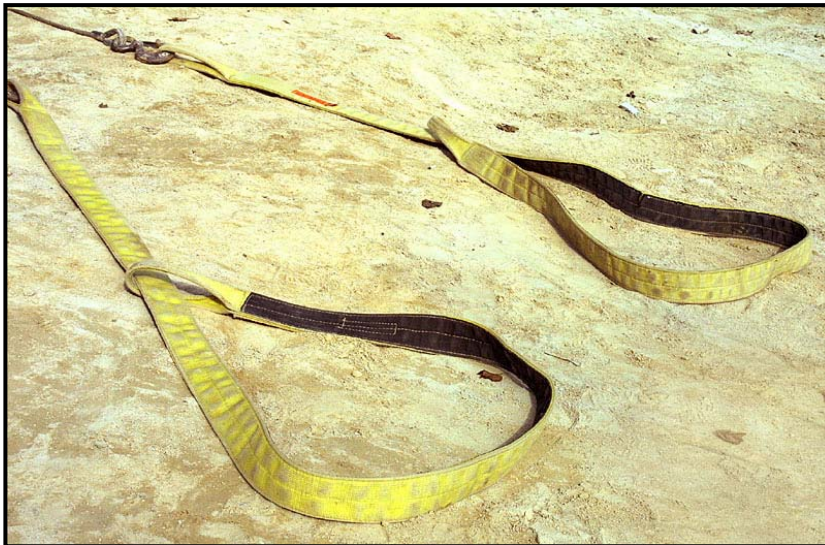
Photo 4 -- View of two nylon slings in typical choker position.

Rigging consisted of a 1½-inch (3.8 cm) master link attached to a two-leg wire rope bridle, which was made of two, ¾-inch (19 mm) wire ropes, 10 feet long (3 m), attached to 10-inch (25 mm) eye hooks (see Photos 4,5). Each eye hook had a five-ton capacity and a safety latch, which was functional on both hooks. The nylon web slings had eyes at both ends, and were configured in a choker hitch around the load of forms, with the free end slipped over each hook. Two workers rigged the slings, hooked the sling ends on the hooks, and one worker radioed for the operator to begin his lift. The load was level, and nothing unusual was noticed at this time, but apparently one of the sling ends was not fully seated within the hook.

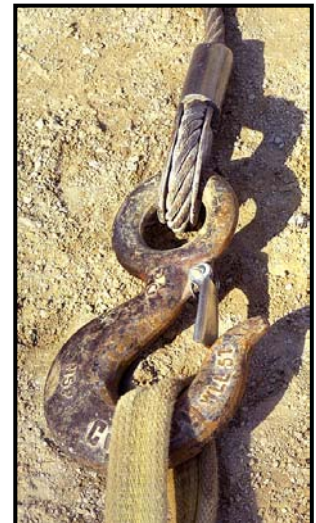
Photo 5 -- Close-up of hook and sling end.

After the incident, the eye hooks, the wire rope bridle legs, and the nylon slings, were inspected, but nothing unusual was found; therefore, the company soon put the equipment back in service. During our investigation, we examined hooks on one of the bridle legs. The safety catches were functional, but had considerable side-to-side play in the hinge. It appeared that if the end of a loop was not fully seated in the hook, the loop end could possibly twist or roll out, pushing the safety catch far to one side, leaving the hook open. Company representatives offered this as one possible reason that the sling failed.

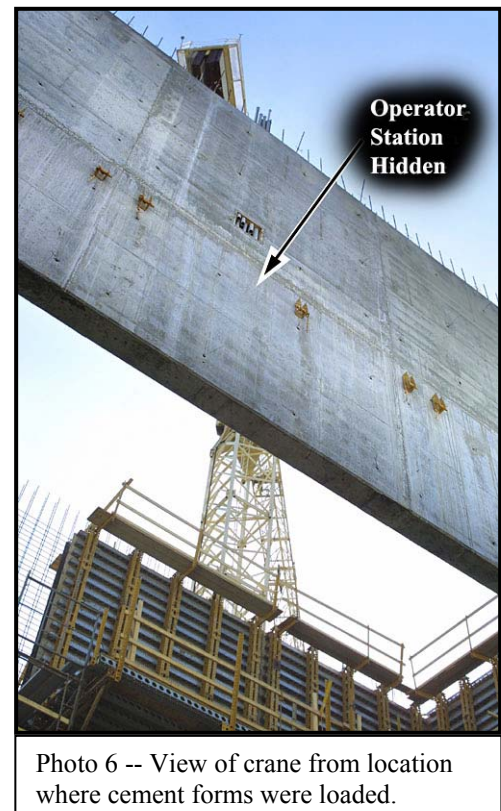
Communication between the crane operator, the person rigging the load, and others at the jobsite must be effective. Crane operators must be aware of all work locations, and likewise, workers should be alerted to stay clear of areas where loads will be moving overhead. The concrete wall (in Picture 6) blocked the crane operator's view to the location where the load was rigged. Even though they had radio contact, lack of visual contact may have compromised communication between the crane operator and the person rigging the load.

Depending on the situation, multiple people at a worksite may need to be involved in communicating where crane traffic will be, and how best to protect workers from the hazards of suspended loads. Effective radio and visual communication between foremen, crane operators, rigging persons, and possibly others at the jobsite, may be needed to avoid hazardous situations. Applicable ANSI hand signals should be used, and illustrations should be posted at the job site (29 CFR 1926.550(4)).

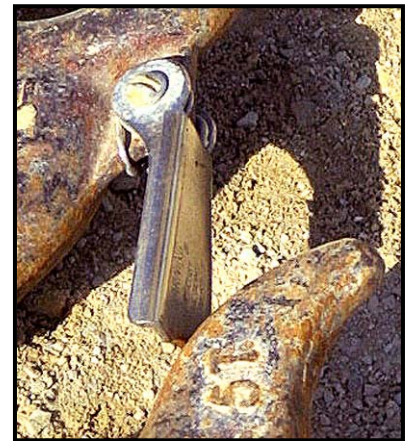
It is critical that a lifting hook has a functioning safety latch. Hooks without latches, or ones with damaged latches are sometimes called "killer hooks" for obvious reasons. Simple hook latches (see Photo 7) are easily damaged during normal use, and may bend to one side or the other compromising their function. Over the years, many new types of hooks have been invented, some with integral self-locking latches. These hooks offer significant protection from latch failure, and would be an excellent option for use in areas of high crane traffic (see appendix). During our investigation we were not able to inspect the actual hook used at the time of the fatal accident.

Photo 7 -- Close-up of a typical spring-loaded latch on a hook.

In this case the load appeared level, and the lift began normally, however, a second careful visual check may have been needed. The rigging failed during the swing to a storage area outside the building, out-of-sight from the worker who rigged the load. It may be possible that during the swing the load shifted and allowed one side of the sling to have less or no weight on it, allowing the sling to roll out of the hook. Although the mechanism of the failure is not known, it is necessary that all rigging be double-checked prior to signaling or radioing for the lift to begin.

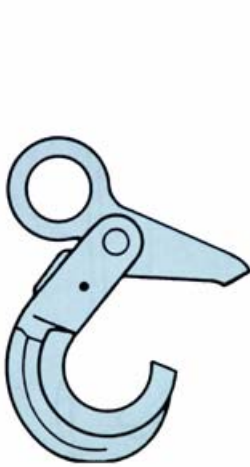
Appendix -- Types of safety hooks. (Reprinted from ASME B30.10-1999 by permission of The Society of Mechanical Engineers. All Rights reserved.)

FIG. 12 SELF-CLOSING FLIPPER LATCH (EYE HOOK)

FIG. 13 SELF-CLOSING TIPLOCK LATCH (SHANK HOOK)

FIG. 14 SELF-CLOSING TIPLOCK LATCH (EYE HOOK)

Since this incident, the company now uses a self-closing tiplock latch (see Fig. 13 in Appendix) for choker loads, instead of flipper latches (Fig. 12). The tiplock latch requires manual insertion of a locking pin, which confirms the sling end is properly seated in the hook.
