FROM: Iowa FACE Program Case No. 00IA08201 Report Date: March 2002

SUBJECT: Farmer Fatally Injured by Rotary Mower When Tractor Seat Falls Off

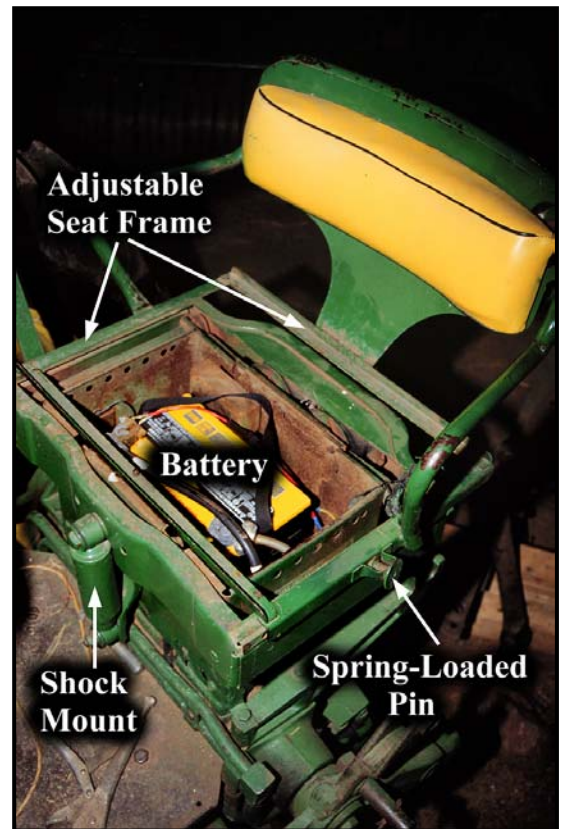
Photo 2 -- Top view of seat showing seat frame, battery housing, and adjustable pin. (cushion removed)

The battery housing forms the base of the seat on this tractor (see Photo 2). A shock-absorbing main seat frame is built around the battery housing. The seat cushion, backrest, and armrests are attached to the top part of the frame, which is adjustable and slides on tracks at the edges of the main frame. A spring-loaded pin on the left side of the seat locks the seat in place (see Photo 3).

Recommendation #1 *Owners/operators of tractors should ensure that the tractor seat is in good condition and firmly attached to the base.*

Discussion: Machines should be kept in good repair, including the seat. The seat on this tractor was in poor condition. The attachment was worn and when driving unexpectedly into a sinkhole in the field the jolt separated the seat from the frame and threw the operator off the tractor. This tractor was used because the regular tractor was in the shop, and this older tractor was adequate for operating the small mower. Older tractors like this are often used for mowing.

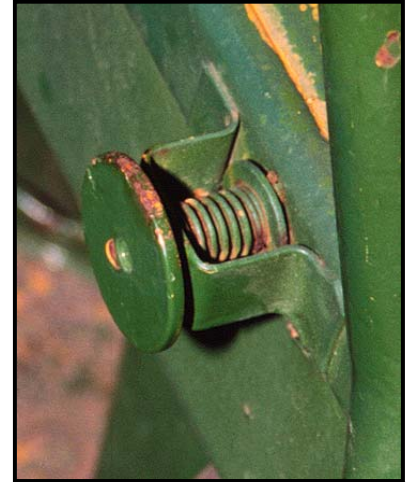
Photo 3 -- Close-up of spring-loaded pin on left side

In the photo, the pin is operational, but according to the victim's relatives, it was damaged, and the tractor was in overall poor condition. We were not able to observe the tractor, so the extent of the damage is not clear, but considering the age of the tractor, many forms of wear and tear could damage the pin.

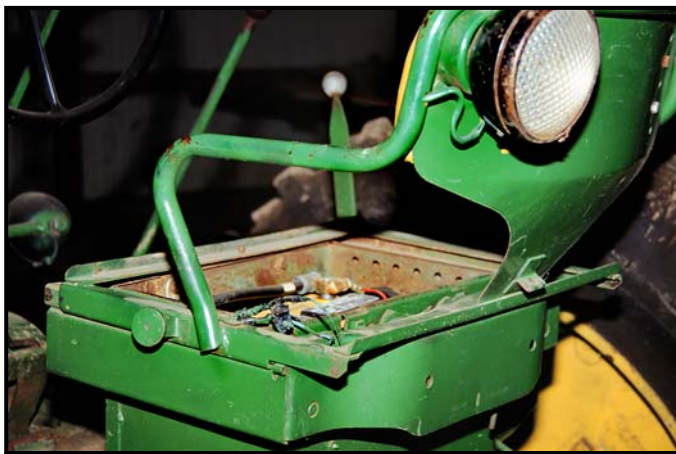
Photo 4 -- View of left side of seat, showing sliding track and armrests welded to the seat edge.

The adjustable top part of the seat frame moves forward and backward on the tracks/grooves. Bent metal tabs at the end of the tracks are designed to keep the seat in the adjustable range. The back and armrests are welded directly onto the sliding top part of the frame (see Photo 4). Over time this seat attachment may become loose, especially if the spring-loaded pin is not keeping the seat in place. The tabs may wear, and the top frame may bend or wear and be more prone for sliding out of the tracks.

Discussion: The seat frame in this tractor was separated from its base during a strong jolt. It appears the seat slid back and the tabs at the end of the tracks were not able to stop it. It's also possible that the adjustable top part of the frame was bent and loose enough that it pulled the seat up and out of the tracks during the jolt. In either case, the seat adjustment mechanism was not secure enough to hold the seat in place. The challenges in manufacturing a tractor seat are significant and include adjustability for various size operators, shock absorption, vibration damping, weather and corrosion resistance, durability, and comfort. Some recent seat models allow the seat to rotate to the right to reduce bending of the back when observing implements behind the tractor. Furthermore, some seats tilt to remain vertical when driving on sloping ground. Regardless of the features of the seat, the construction of the seat frame and its support structure should be able to withstand use in demanding conditions.

Recommendation #3 *Equipment manufacturers should design the seat support structure to withstand use in demanding conditions for the lifetime of the tractor.*
